Yap Island

Coastal Degradation Assessment Report

**Developed for UNDP GEF 5
Ridge to Reef Project**

September 29, 2017

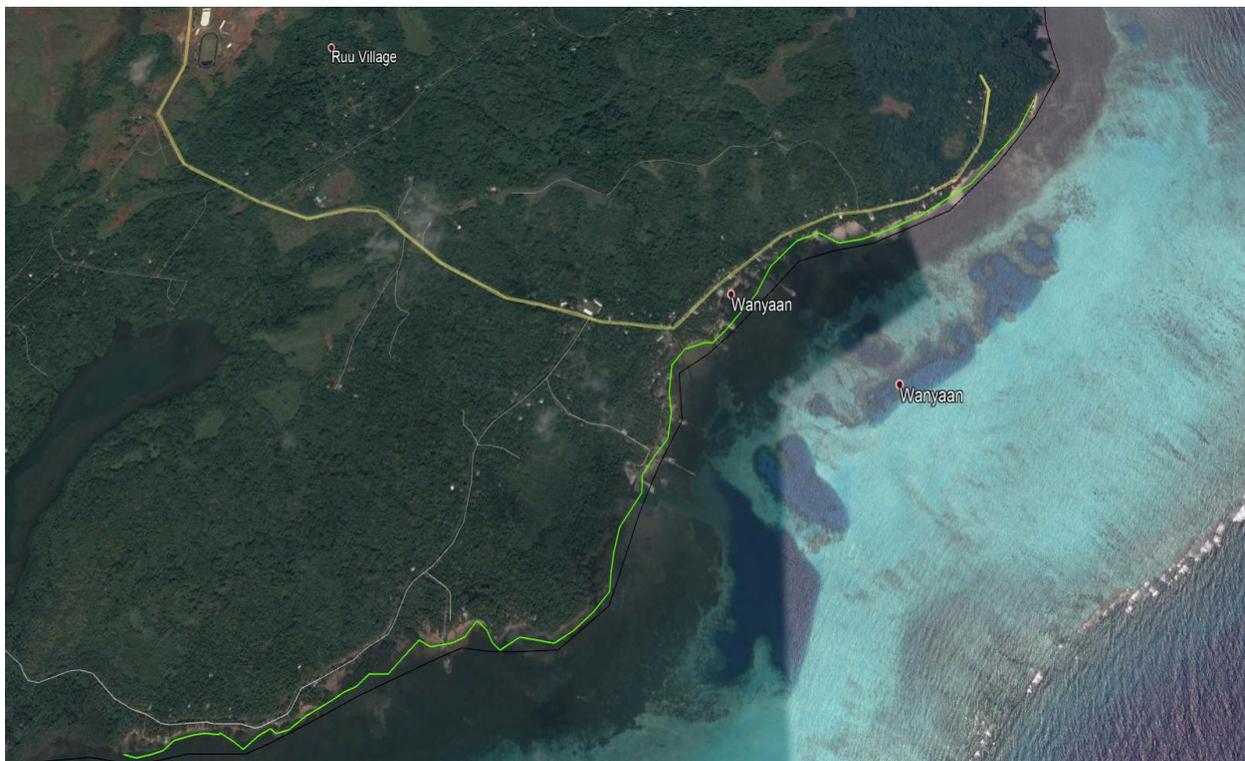
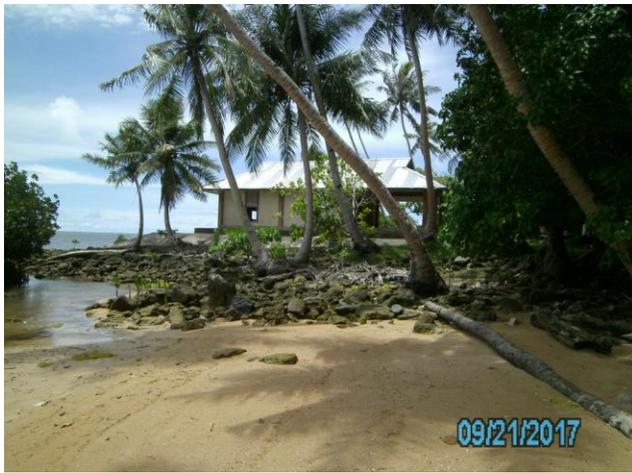
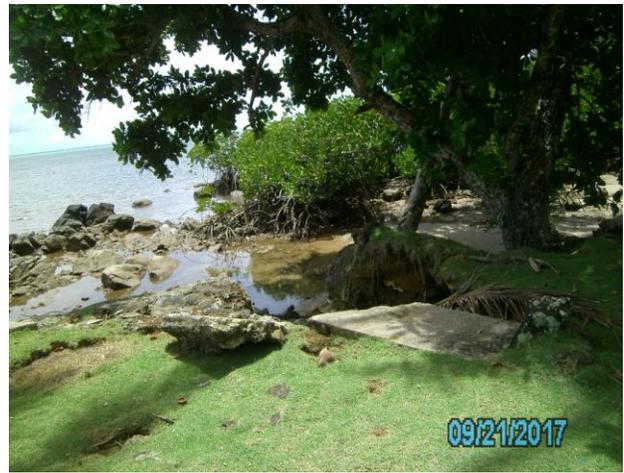
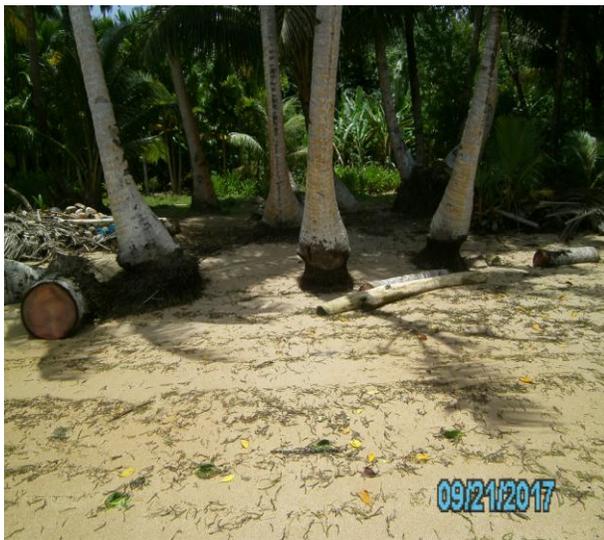
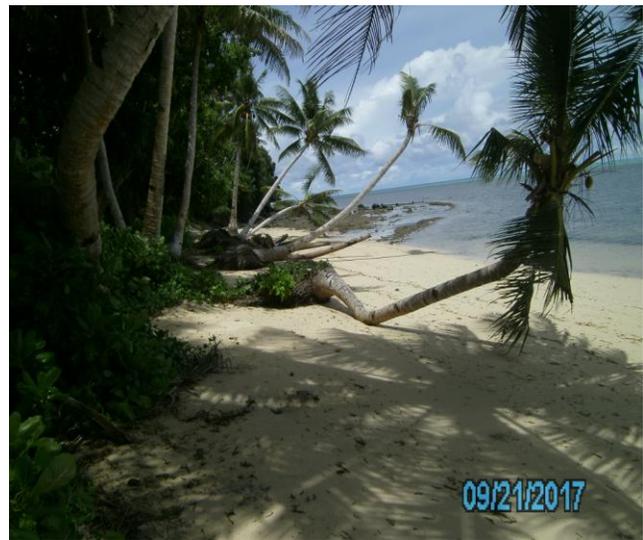
The affected areas in Gagil cover an area equals to 3 miles. In some areas it is evident that as much as 20 feet and as little as 4 feet have been eroded away. Based on information gathered from interviewing some of the local residents (those who were present on the boat and or in the car) during the survey, those areas slowly eroded away over the past 20-30 years. Information sources revealed that the frequency of typhoons and sea level rise within the last 10-15 years have greatly contributed and magnified the erosion issue. It is worth noting that most of these impacted areas are in places where the coastline is exposed and has no protection from mangroves or mangrove patches.

The former shoreline areas are evident from the lining of the dead and fallen coconut trees and other big trees which are 20 feet from the current shoreline. Constructing a timeline to determine the erosion rate is difficult as there is no available data to help.

Below are photos from couple of the heavily affected sites in Gagil Municipality. These photos were taken from the shoreline during the follow up visit to the heavily impacted sites located in Gagil Municipality.

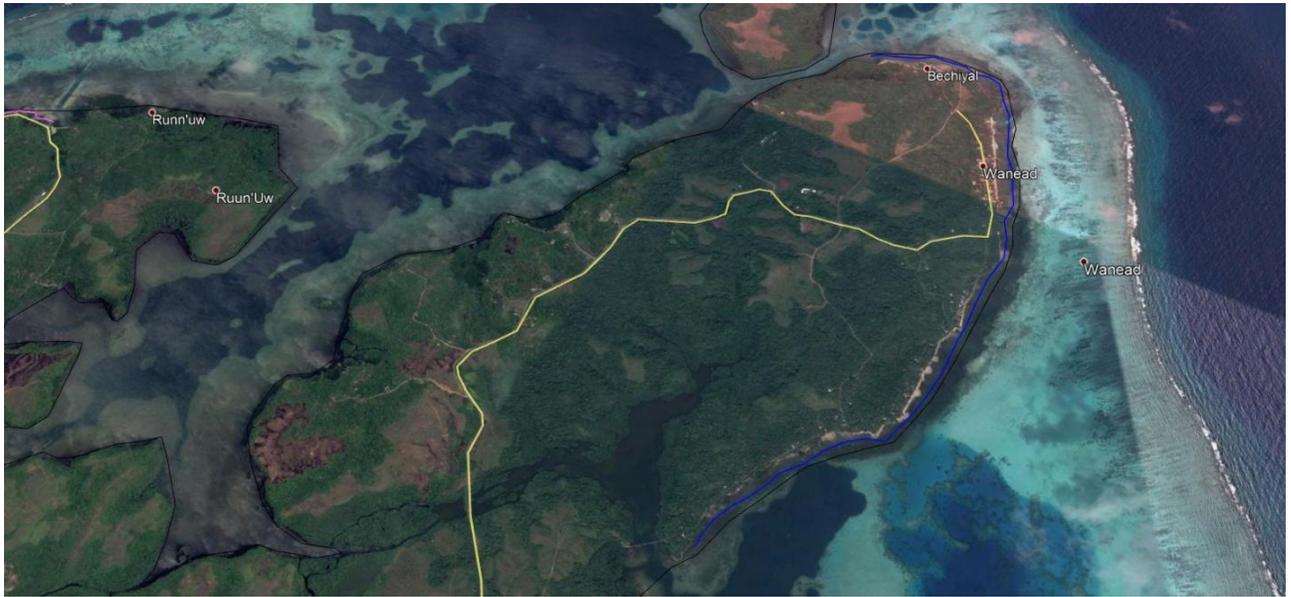
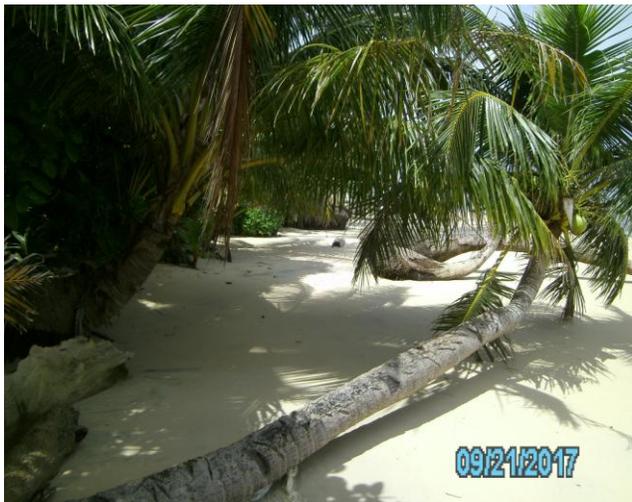
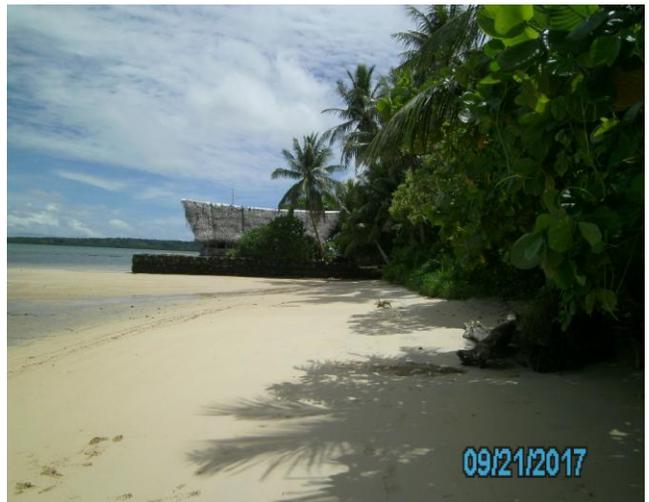
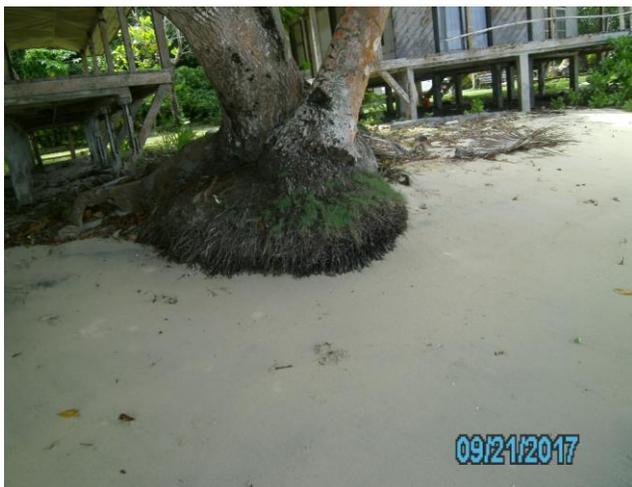
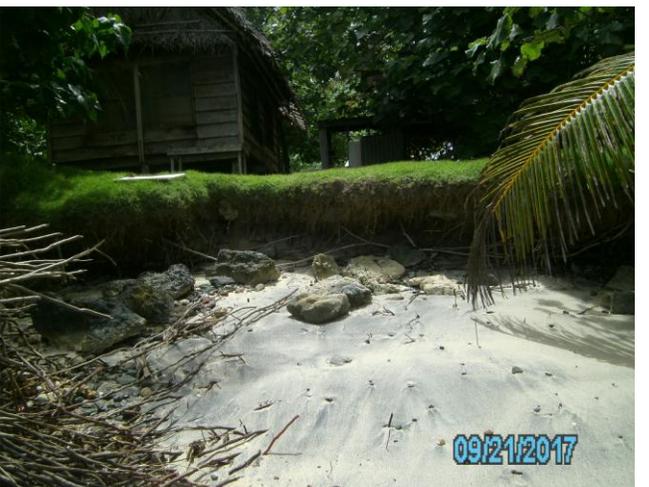
Maap is located on the most northern part of the island. 4 miles of eroded areas are found in this area. As shown in below photos, Maap is most vulnerable with very little protection from mangroves and the reef. Mangrove patches does not exist in most areas as most of the coastline is covered with sand which can be most susceptible to erosion and may not be the best for trees to grow and help hold the soil and coastline.

Whether mangroves survived at some point in the eroded areas is unsure but it is definitely not there when it was surveyed. Although some people are recently forced to rebuild and move further inland after the previous typhoons, some people still live close to the water for better access to the water.

A solid landmark to measure how much has been eroded away is the Village View Hotel in Chool, Maap. The hotel was built in the mid 1990s. It was built on a location approximately 50 feet from the shoreline. In 2017, during the time of this assessment, the shoreline has moved 10 feet past the foundation post of the cottages which were closest to the shoreline. Based on these given facts, the soil is eroding at a rate of 0.08 inches on a daily basis; 32.4 inches per year.

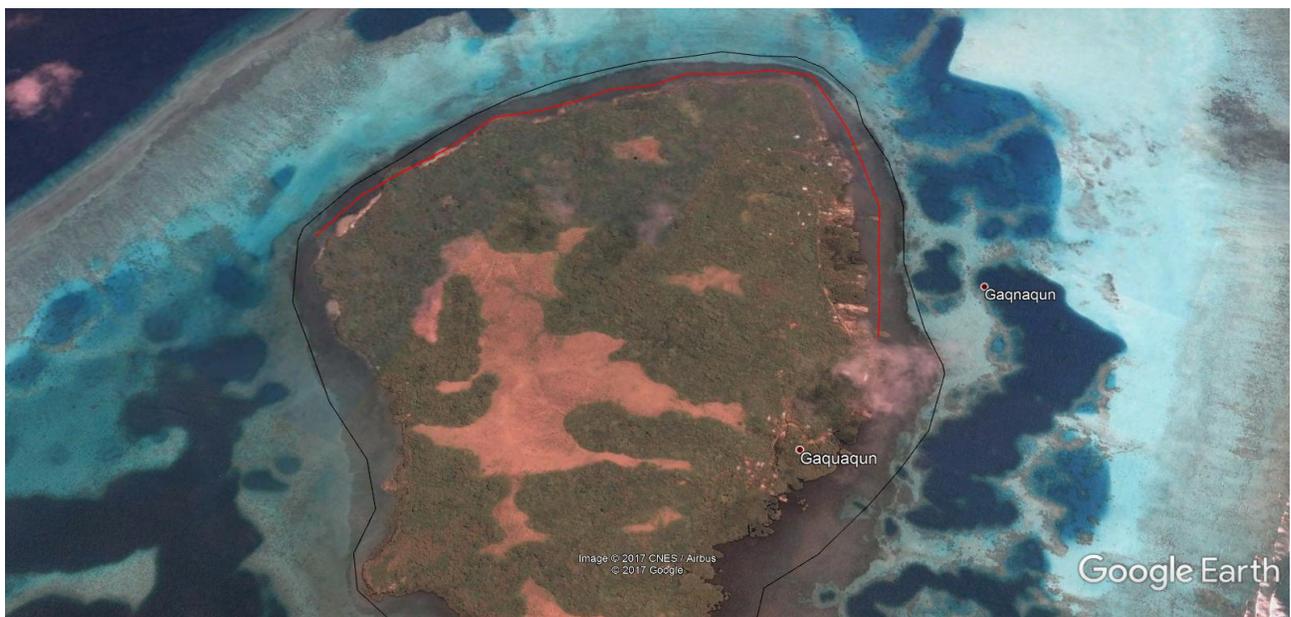
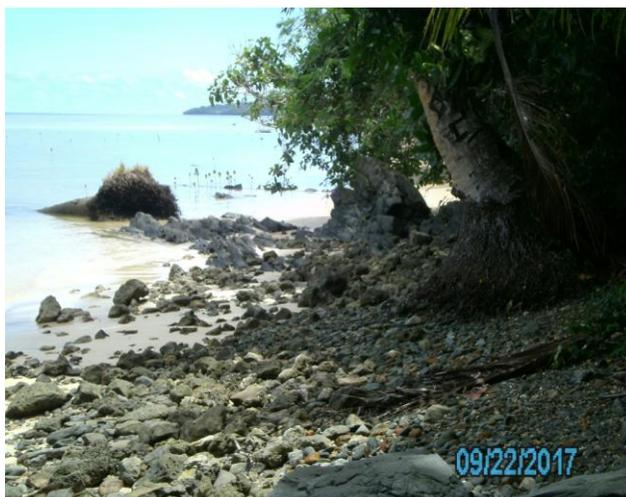
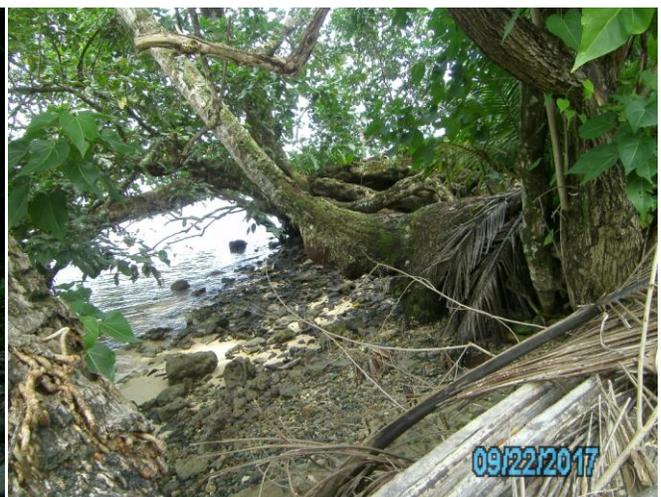
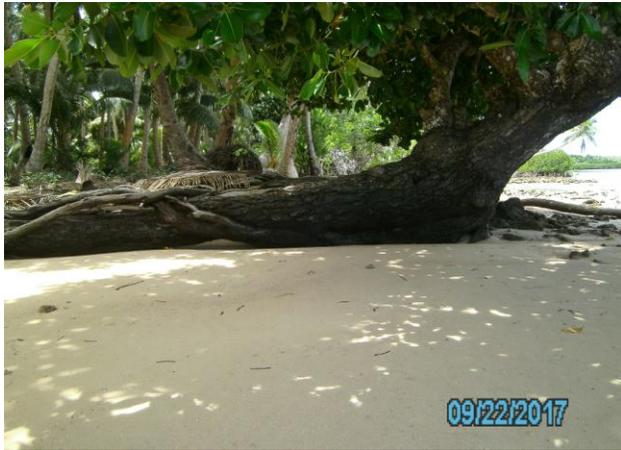
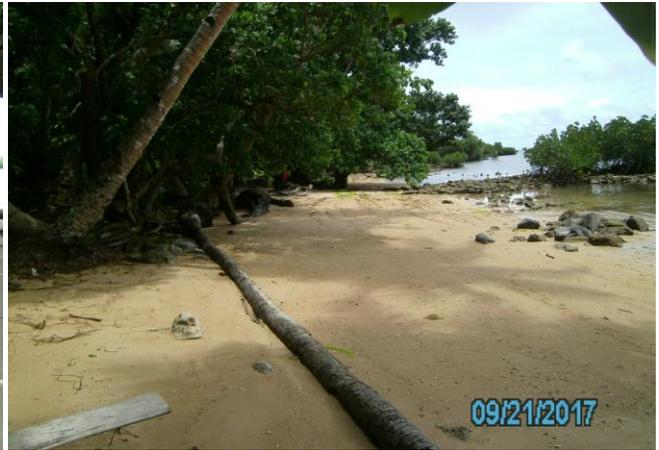
Rumung

One half of the island's shoreline is protected by mangrove patches while the other half, the side exposed to the reef, is bare and has no coastline protection. As being exposed to the breaking waves on the reef, most of the coastline erosion is happening on this same side. The reef to shore is closest at approximately 0.3 miles. The farthest reef is approximately 0.8 miles to shore. The erosion affected areas amount to a little over 2 miles, 2.15 miles to be exact.

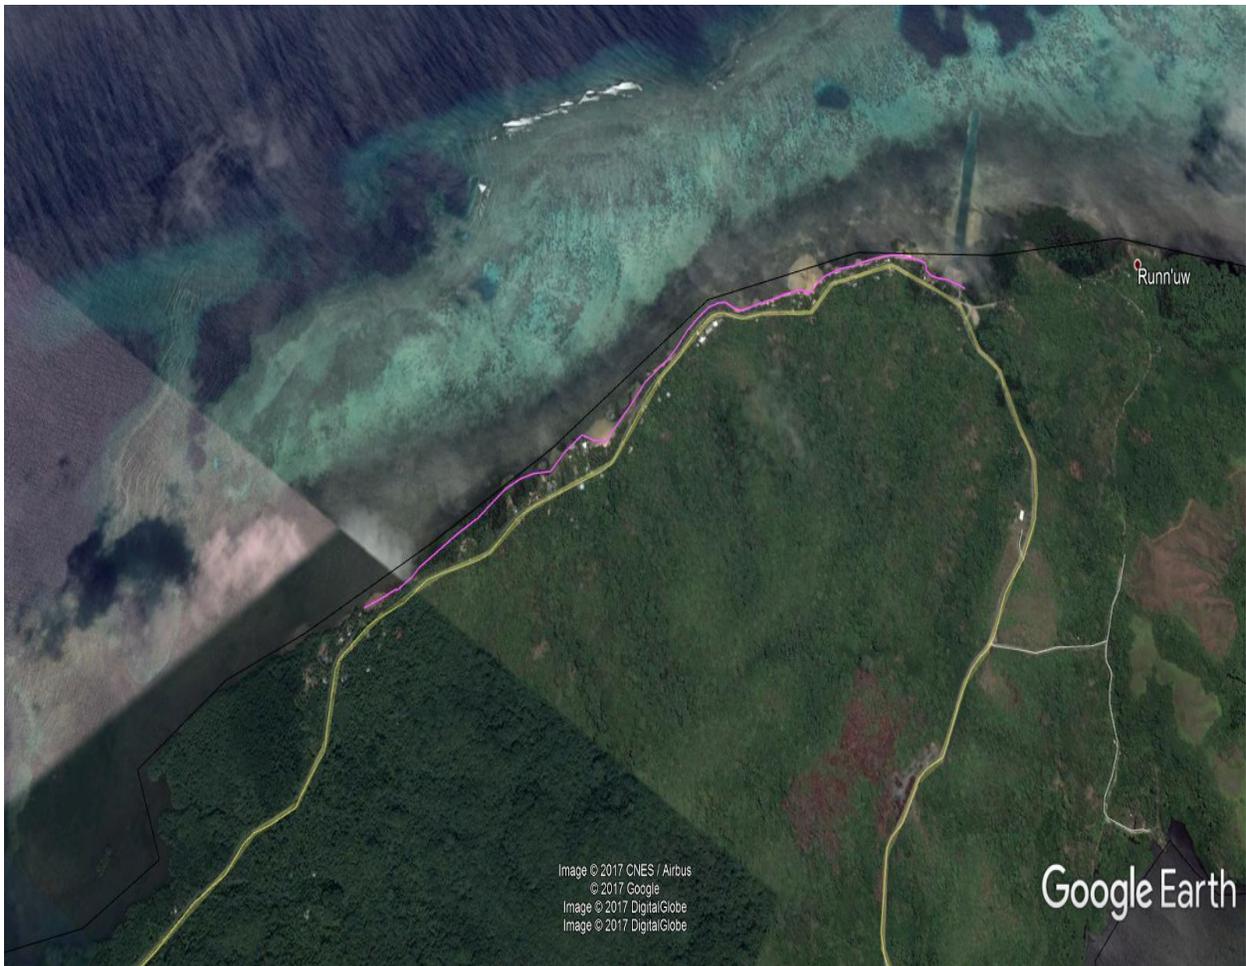
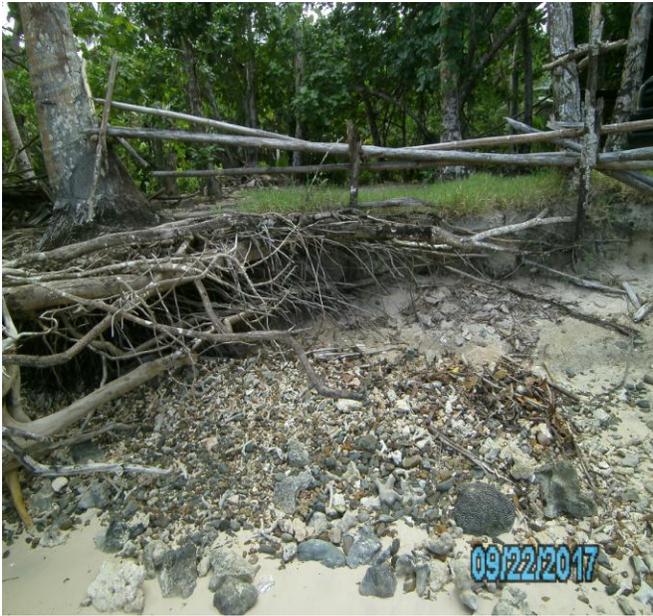
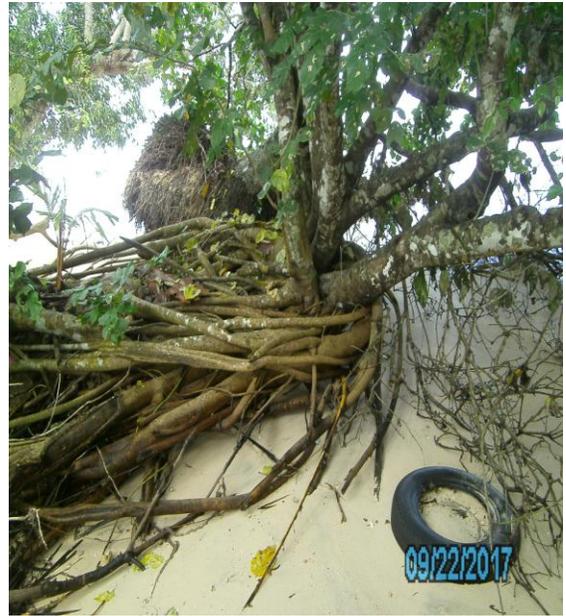
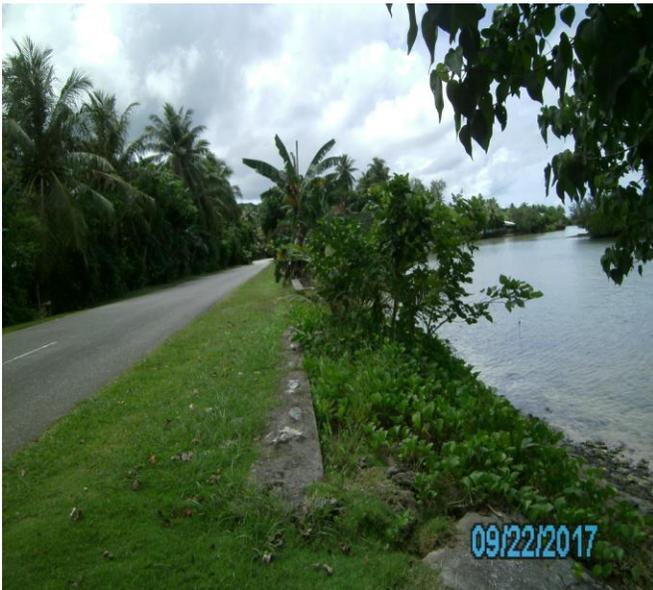
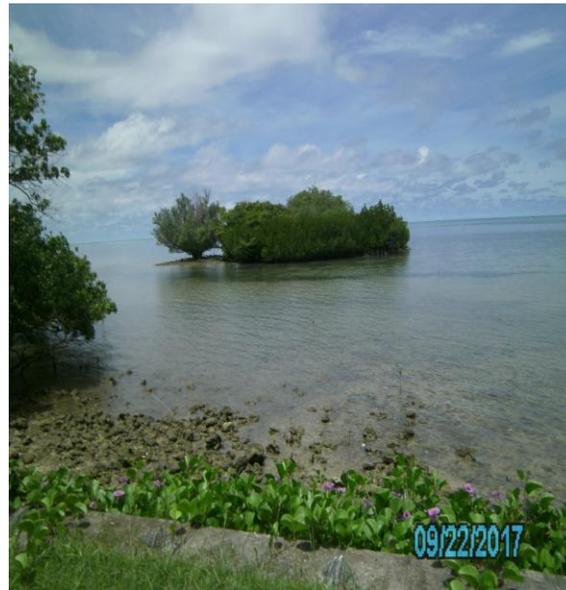
Fanif is located on the north western side of the island. It is one of the areas on the island that has the closest breaking waves to the shoreline. The closest reef end is approximately 500 feet away from the shoreline. 1.6 miles of the coastline is affected by shoreline erosion. As being closest to wave action breaking on the reef, this is one of the highly vulnerable areas around the island.

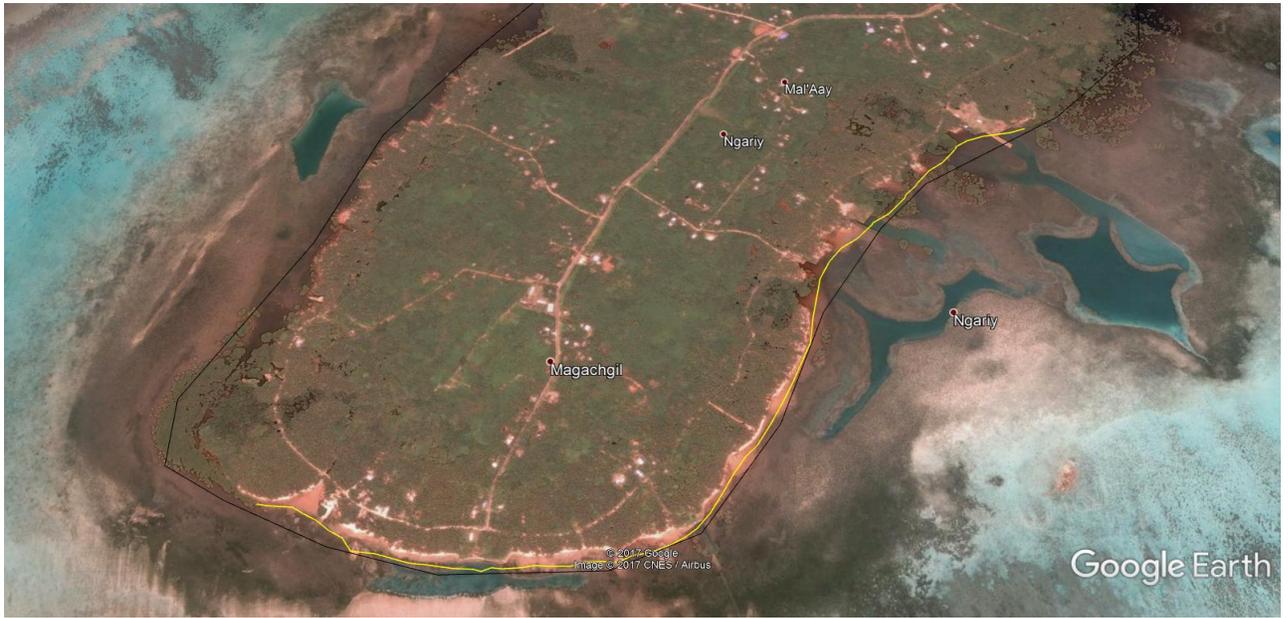
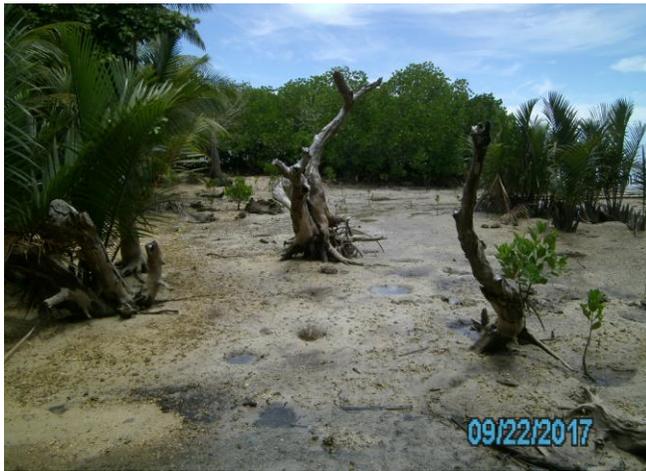
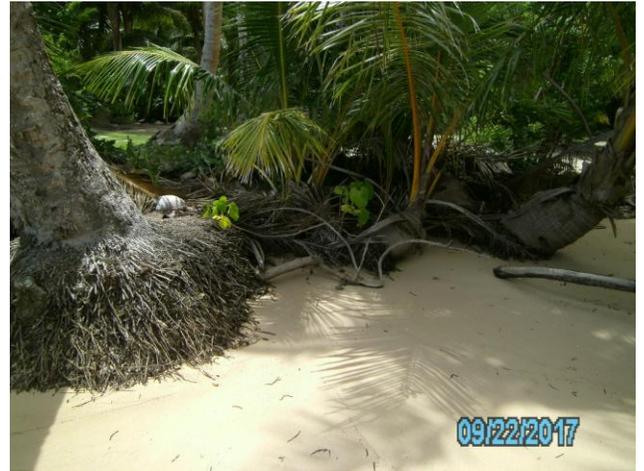
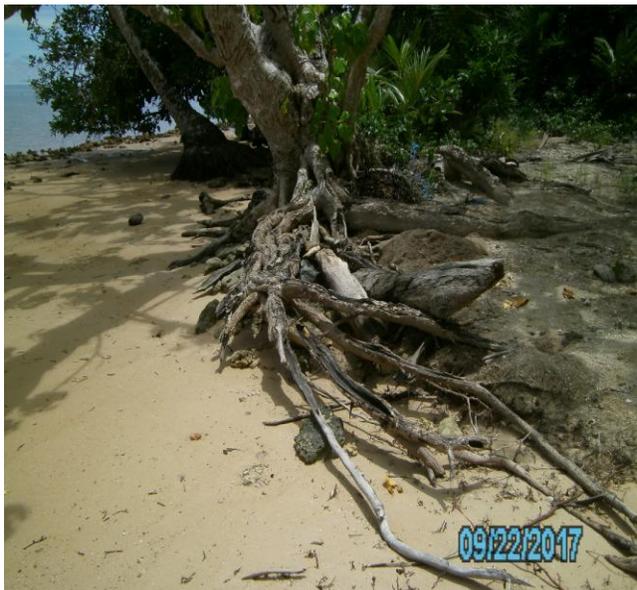
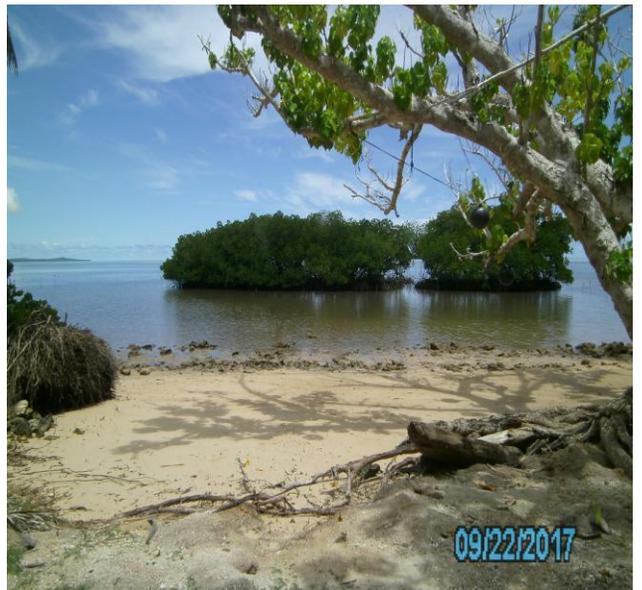
The erosion affected areas in Gilmaan and Ruul amounts to 2 miles. The affected areas are, like the rest of the other affected areas in the different municipalities, exposed to the wave action caused from the breaking waves on the reef. In the areas where the coastline is protected with mangrove patches, erosion or coastline degradation is considerably less than the exposed areas.
