Tagabe River Catchment Management Plan 2017- 2030

With great pleasure, I present to you the Tagabe River Catchment Management Plan 2017 – 2030 which has been prepared by the Department of Water Resources and the Department of Environmental Protection & Conservation and approved by the Tagabe River Management Committee (TRMC) and the Ministry of Lands & Natural Resources. It provides guidance and directions on the way the Tagabe water source will be managed.

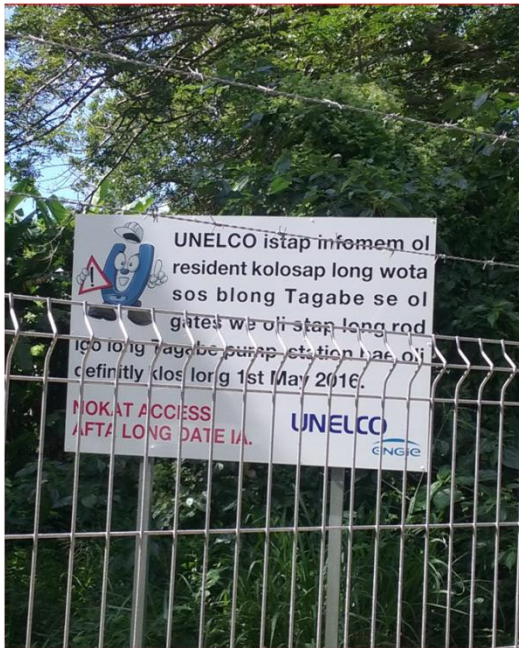
To protect the pump station and bore holes within MWPZ Zone 1, a fence was installed along the perimeter. The fence also prevents neighbouring residents and communities from short-cutting across the MWPZ to access the Tagabe area. Notice boards have additionally been placed along the MWPZ Zone 1 to alter communities that it is prohibited to enter the zone.

Signage in TRCA Zone 1 (UNELCO, 2017)

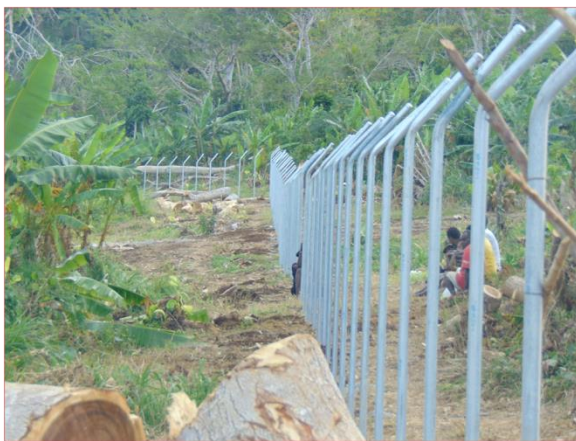
Since its installation, fences have had holes cut into them to allow communities to short cut across the MWPZ, or enter the Zone 1 to trees cut down for firewood or building materials, and to access fruits trees in the botanical garden. UNELCO regularly repairs fences, however repairs have been costly and unsustainable. Guards patrol the area; their boundary is limited to MWPZ 1.

Fencing along Zone 1 (UNELCO, 2017)
