Coastal Water Quality Assessment Report: Rapid Assessment of Priority Coastal Areas for Hihifo, Tongatapu, Kingdom of Tonga

Prepared by Sesimani M.T. Lokotui

Produced and reviewed by GEF Pacific International Waters Ridge to Reef Regional Project,
Pacific Community (SPC), Suva, Fiji

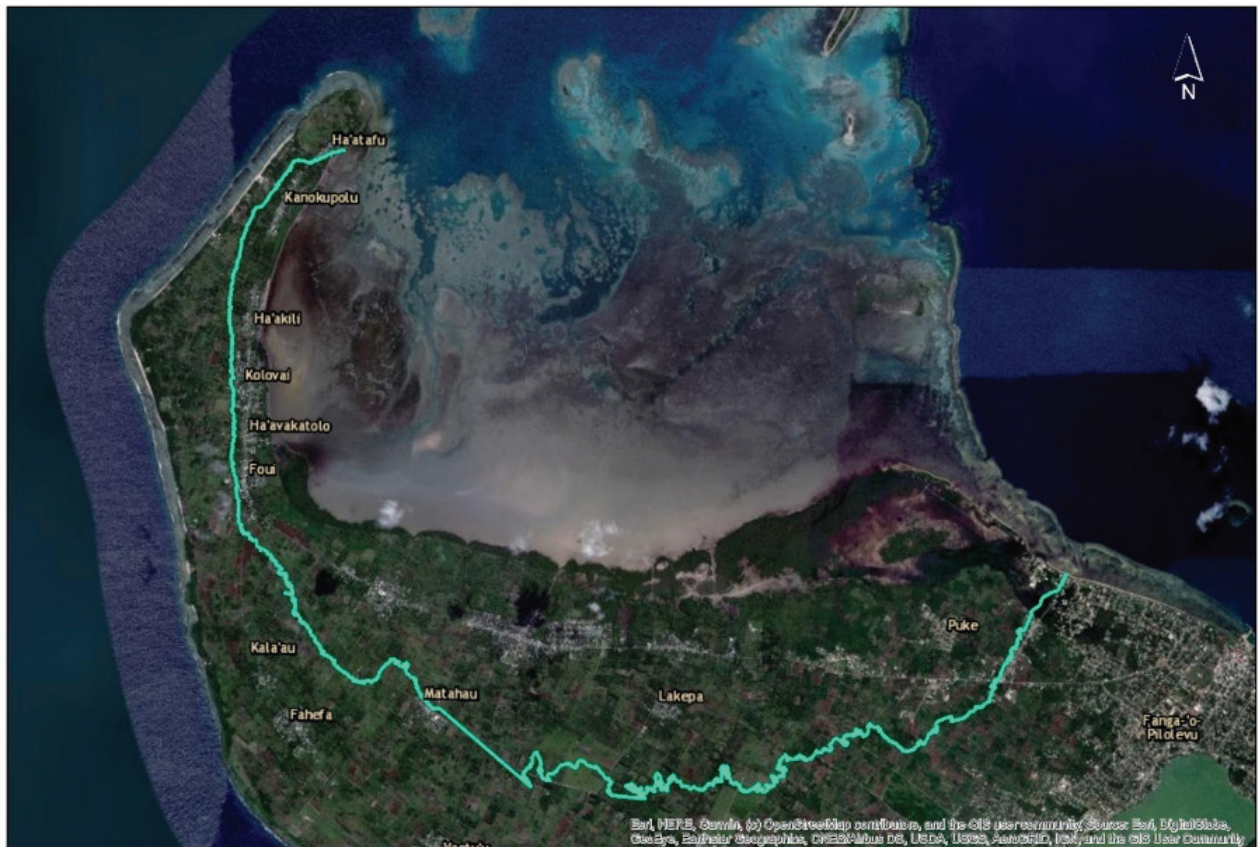
Figure 3. Hihifo Water Catchment Map depicting the area of the Catchment and highlighting the extent of activities on land that can impact on the Hihifo lagoon.

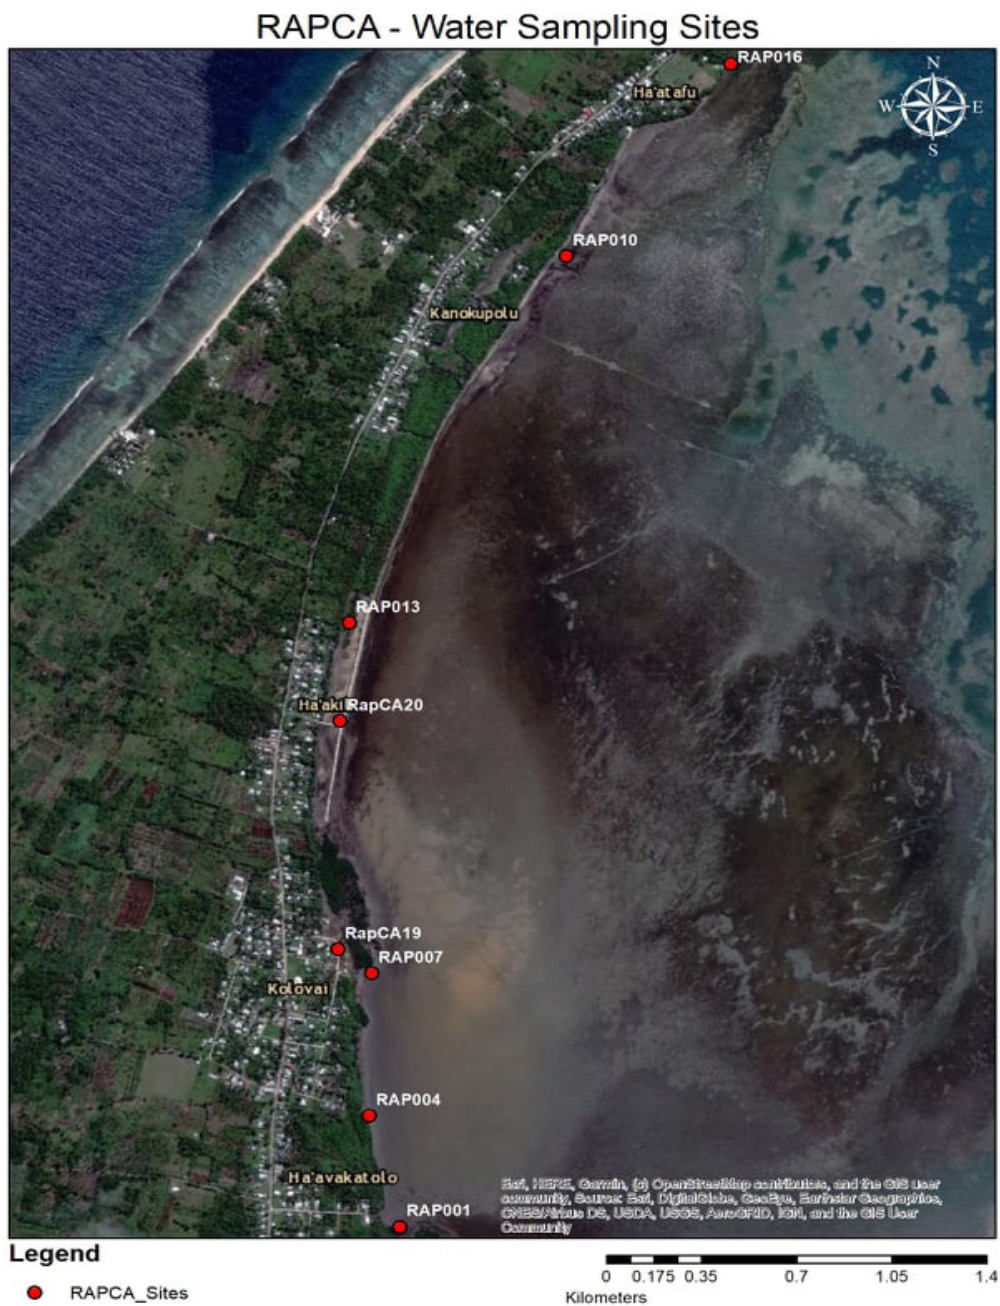
Figure 5. A total of 8 water quality testing sites along the Coastline of the Hihifo Peninsula

Eight sites were thus confirmed for the on-site testing and sampling for microbiological, nutrient and metal contaminants for 23 May 2020 (Figure 5).

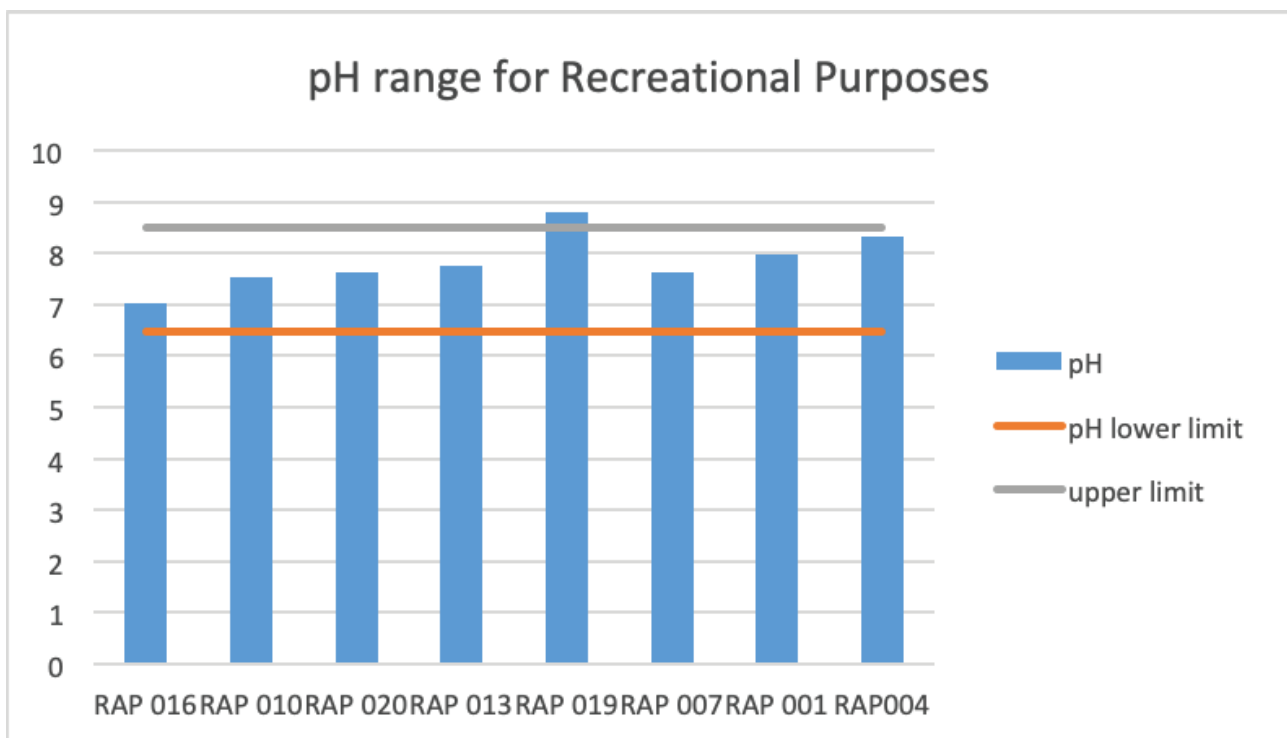
Figure 7. pH results of the 8 test sites showing lower and upper limits for recreational purposes.

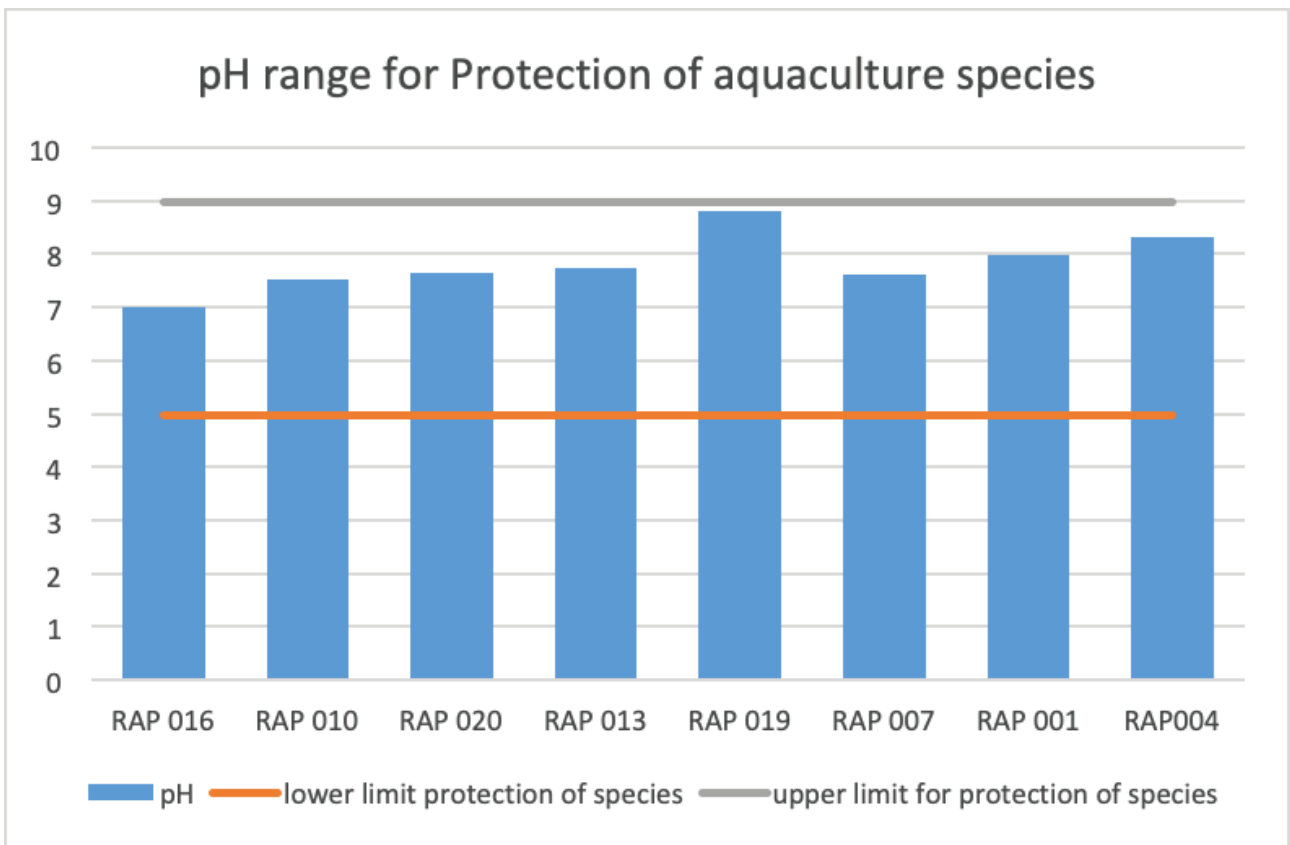
Figure 8. pH results of 8 test sites showing lower and upper limits for protection of species.

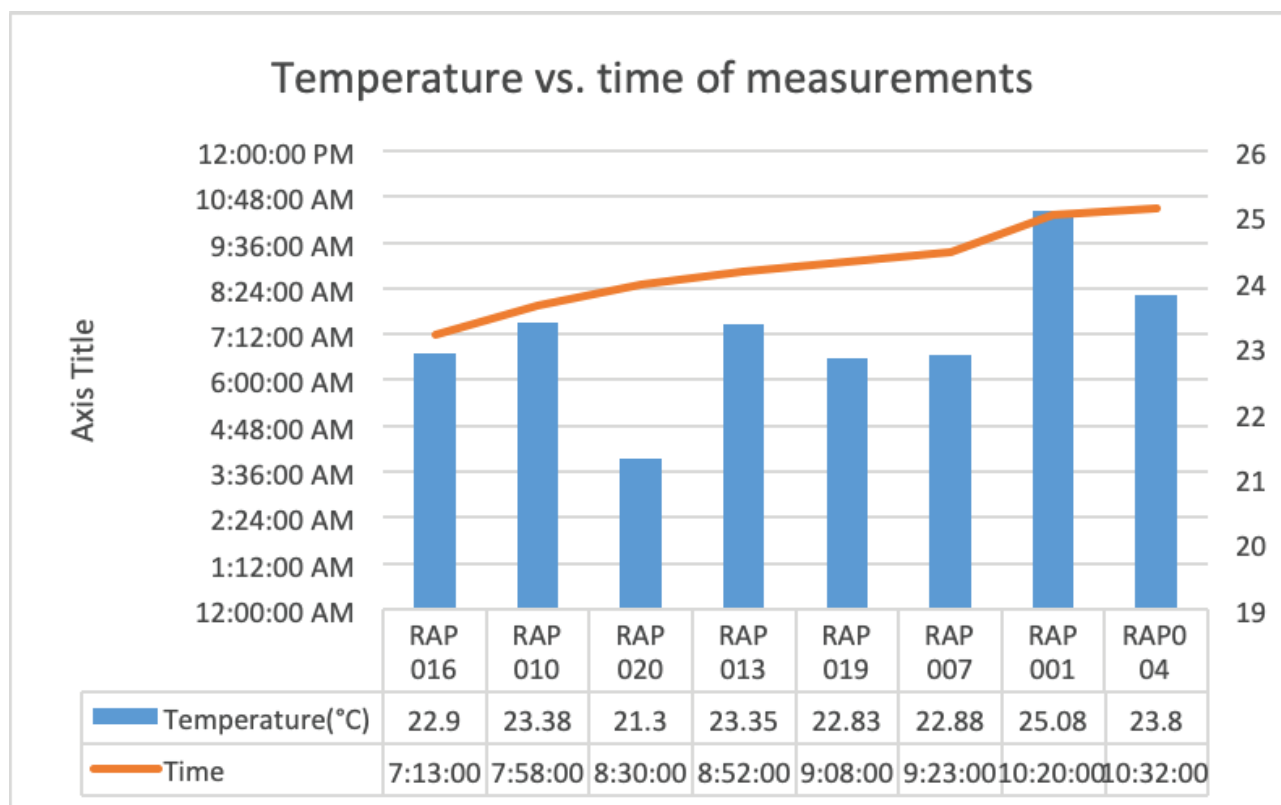
The temperature of the water measured at each site was within normal range for the time of testing. The variability of temperature was dependent on the time of day that the measurements were taken and the surroundings of test site. Factors such as water depth and type of water body being tested explains the trend seen in Figure 10.

Figure 10. Temperature measurements results from 8 test sites. The temperature is graphed against time of measurement.

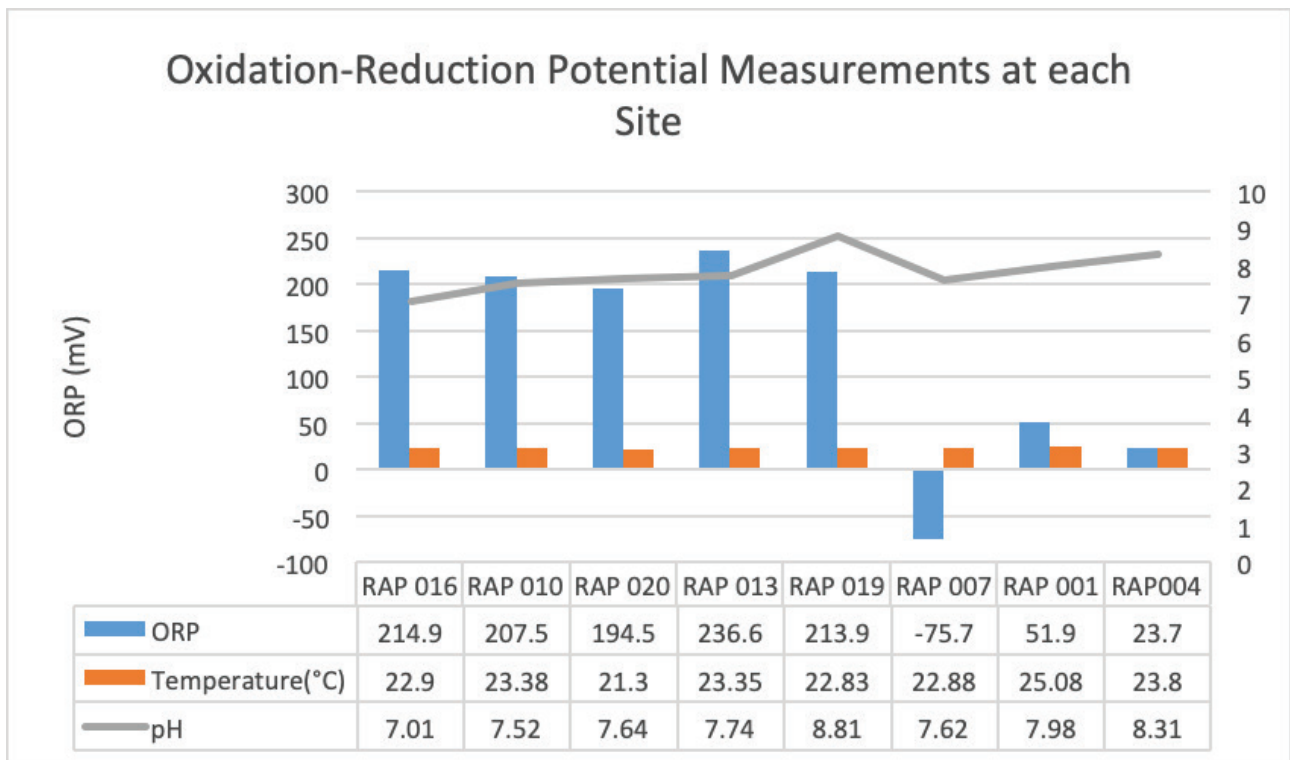
The measurements from the remaining RapCA sites indicate reactions of nitrification occurring in the water.

Figure 11. ORP measurements at 8 sites. ORP is graphed together with the pH and temperature measurements in each site to show the relation between these calculated values.

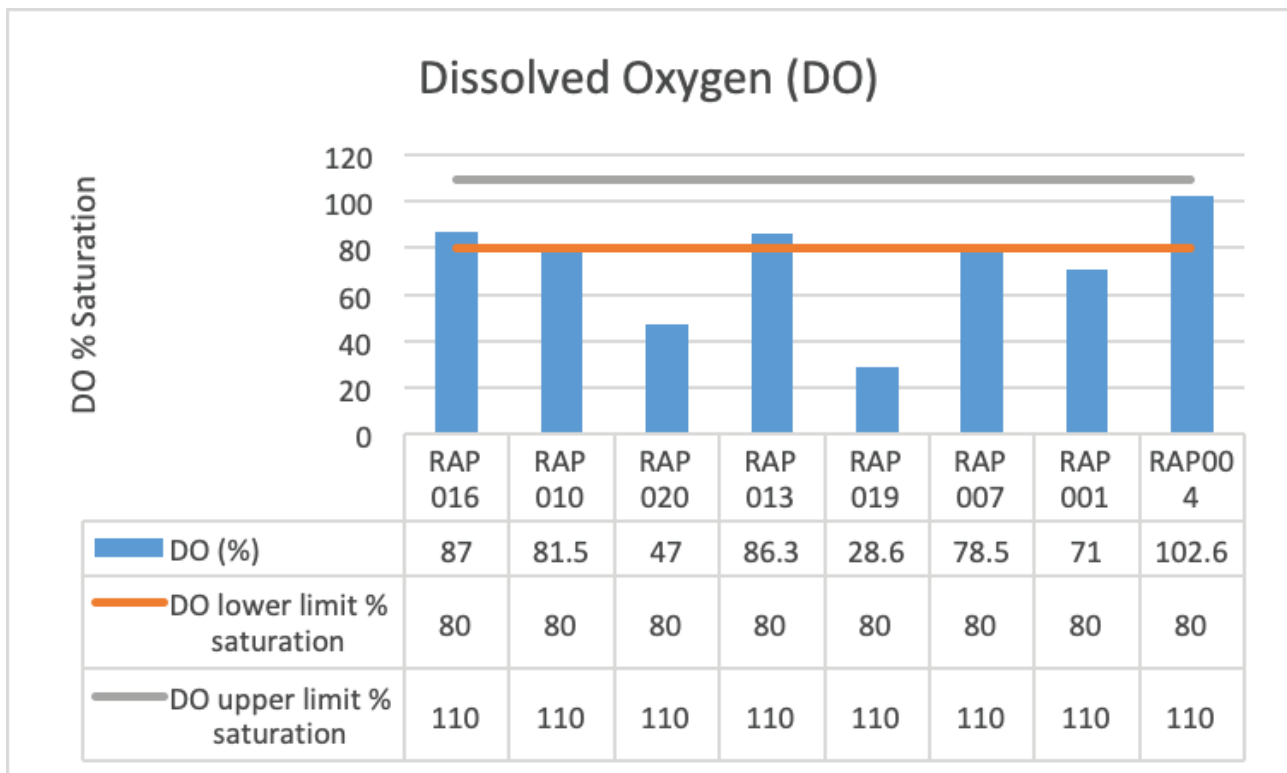
Figure 13 shows the dissolved oxygen measurements at eight sites against the lower and upper limits of dissolved oxygen in per cent saturation. Trigger values are used to assess risk of adverse effects due to nutrients, biodegradable organic matter, and pH in various ecosystem types. The results show that RapCA sites 020, 019 and 001 are below the lower limit for trigger values provided by the ANZECC/ARMCANZ (2000).

Figure 13. Dissolved Oxygen in % saturation measurements at 8 sites. The upper and lower limit for trigger values for physical and chemical stressors for estuaries-like ecosystems like that of the Hihifo Coastline.

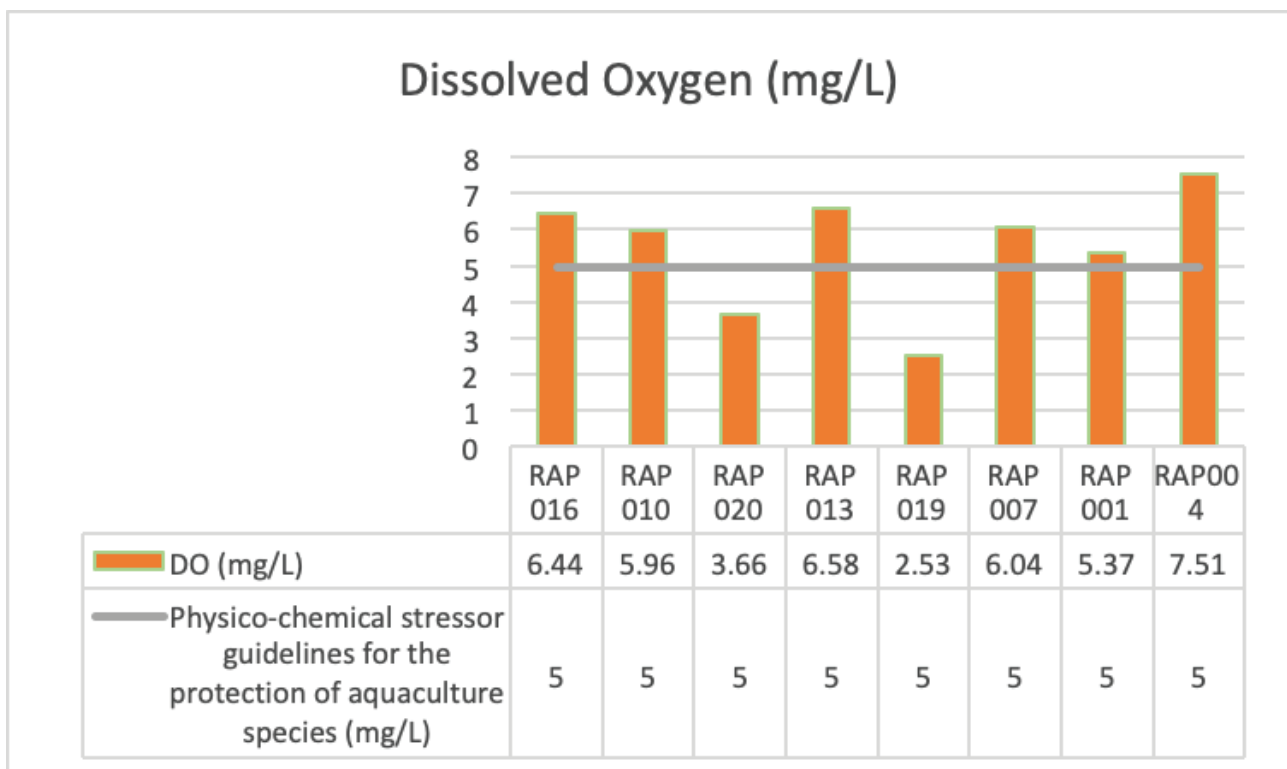
Except for RapCA sites 020 and 019, the DO (mg/L) measurements at all sites are above the guideline value provided for the protection of aquaculture species (Figure 14).

Figure 14. Dissolved Oxygen measurements in milligrams per litre at 8 sites

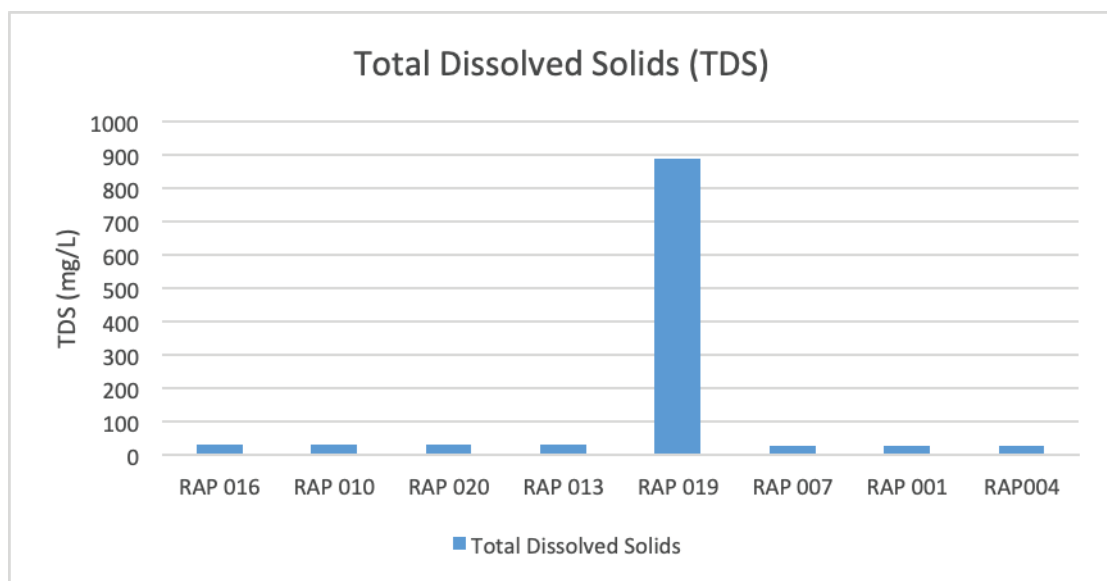
The Total Dissolved Solids (TDS) measurements across the eight sites are shown above in Figure 16. The TDS at RapCA 019 is very high, confirming RapCA Site 019 as a pond water collection for rainwater and runoff from the residential land upon it sits.

Figure 16. Total Dissolved Solid measurements across 8 sites.

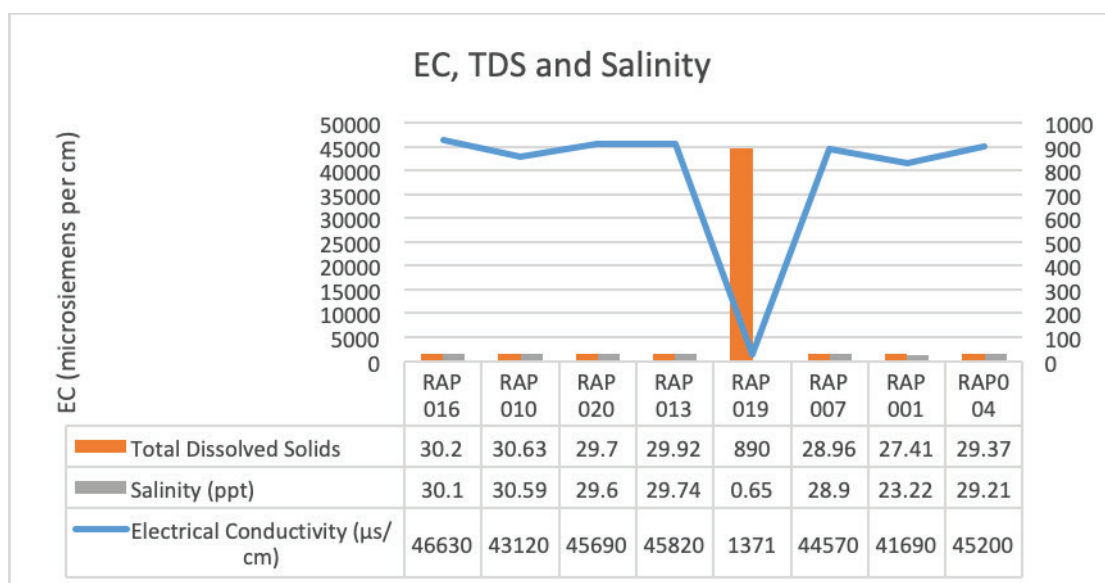
Figure 17. Total Dissolved Solids graphed together with Electrical Conductivity (EC) and Salinity

Figure 17 further confirms RapCA 019 as a collection of rainwater and runoff as the Electrical Conductivity (EC) and Salinity measurements are indicative of freshwater and not saltwater as commonly found along the coastline. It can be explained that due to the nature of the pond water being enclosed and collecting runoff and rainwater, it is expected the dissolved solids over time will be high.

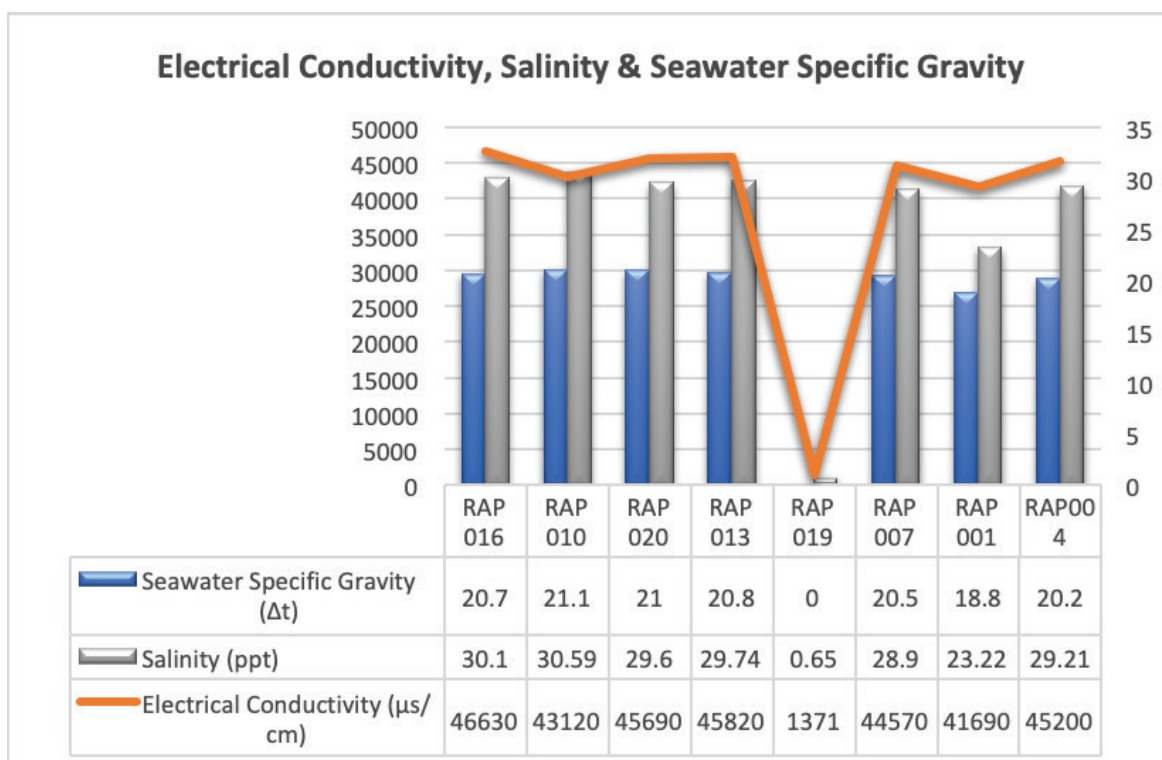
Figure 18. Graphed results of Electrical Conductivity, Salinity and Seawater Specific Gravity.

Electrical Conductivity (EC), Salinity and Specific Seawater Gravity (SSG) are all relative indicators of saltwater. As seen from Figure 18, all the measurements for each RapCA site are in line with coastal water testing confirming conditions indicative of coastal water. The exception is RapCA site 019. The results further confirm RapCA 019 as pond water collection of rainwater and runoff.

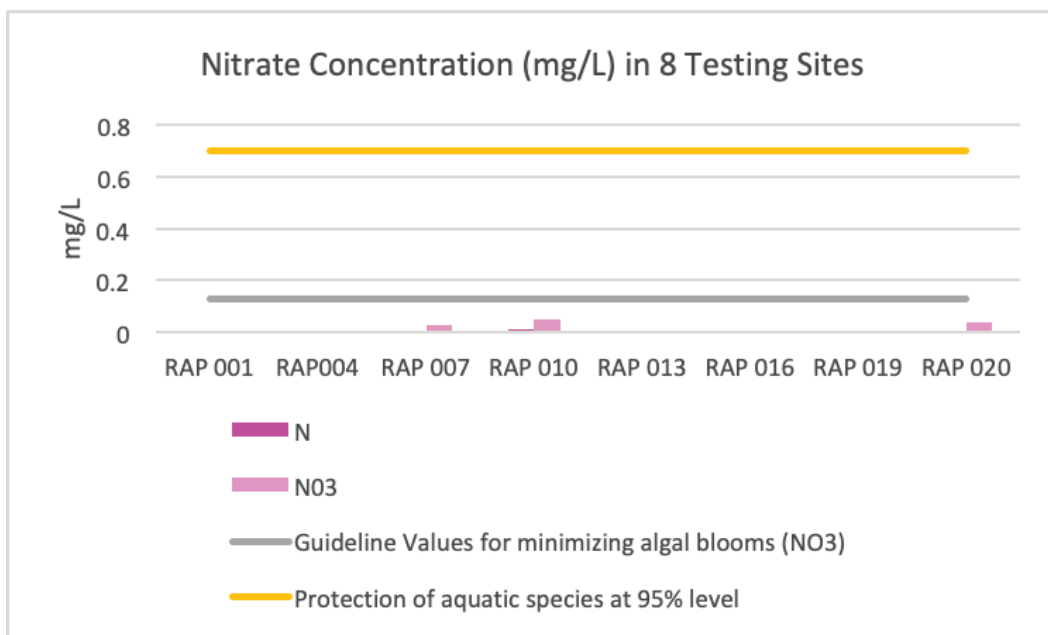
Figure 19. Nitrate results for the 8 sites graphed against the guideline values for minimising algal blooms and protection of aquatic species at 95% level. “N” in darker shade of pink represents the Total Nitrogen found in the form of Nitrate (NO₃) per sample tested from each site.

Figure 19 shows that the nitrate levels at all RapCA testing sites were below the guideline values provided by ANZECC/ARMCANS (2000). It is noteworthy that while the nitrate levels were extremely low at RapCA 007, 010 and 020, **no** nitrate levels were detected for the remaining RapCA Sites. This aspect of the water quality assessment findings needs further investigation.

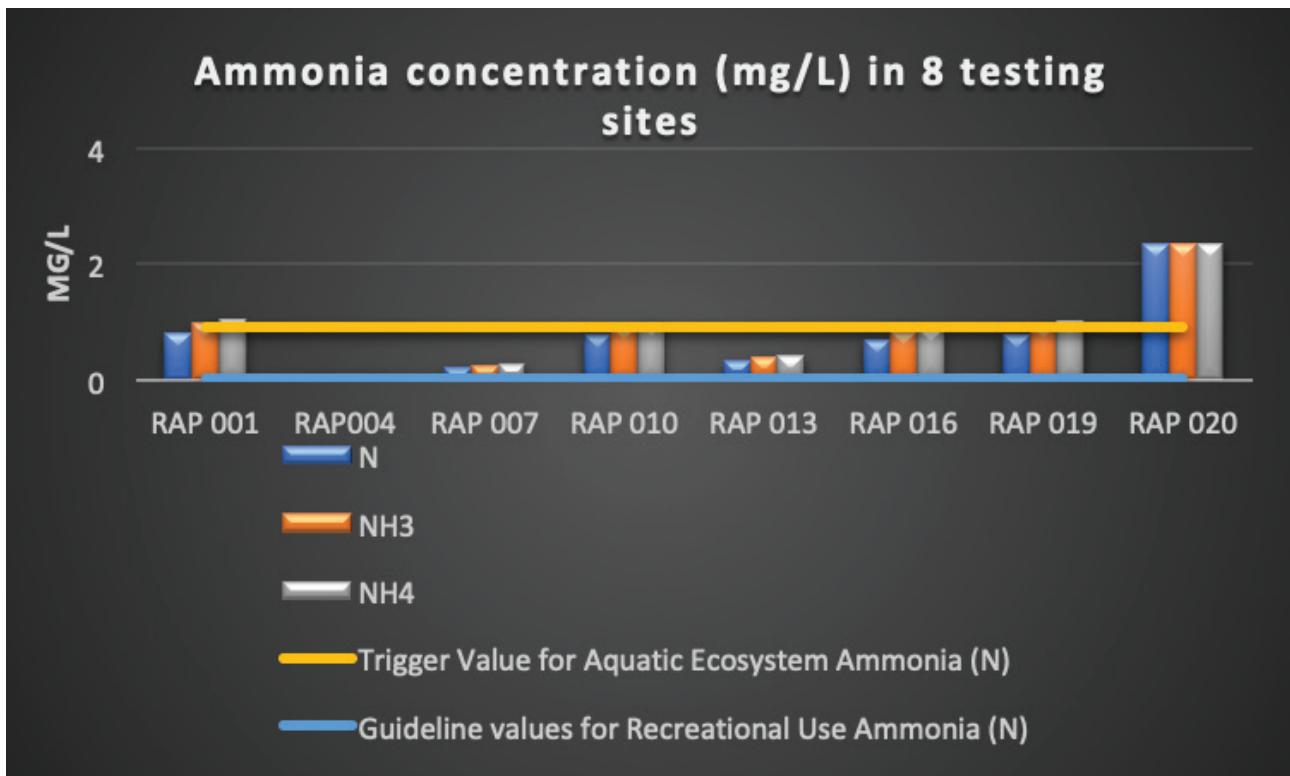
Figure 20 shows the ammonia concentration across the eight testing sites graphed against the guideline values discussed above. The trigger values for the protection of aquatic ecosystems were breached in RapCA site 020. The concentrations at RapCA Sites 001, 010, 016 and 019 were very close to the trigger value. RapCA Sites 004, 007 and 013 were well below the trigger value for aquatic ecosystems. However, all testing sites were determined to be above the guideline values for recreational use.

Figure 20: Ammonia concentration across 8 RapCA testing sites graphed against the Guideline values for Aquatic Ecosystem and for Recreational Use of Water. “N” in bright blue, represent the Total Nitrogen found in the form of NH₃/NH₄ per sample tested from each site.

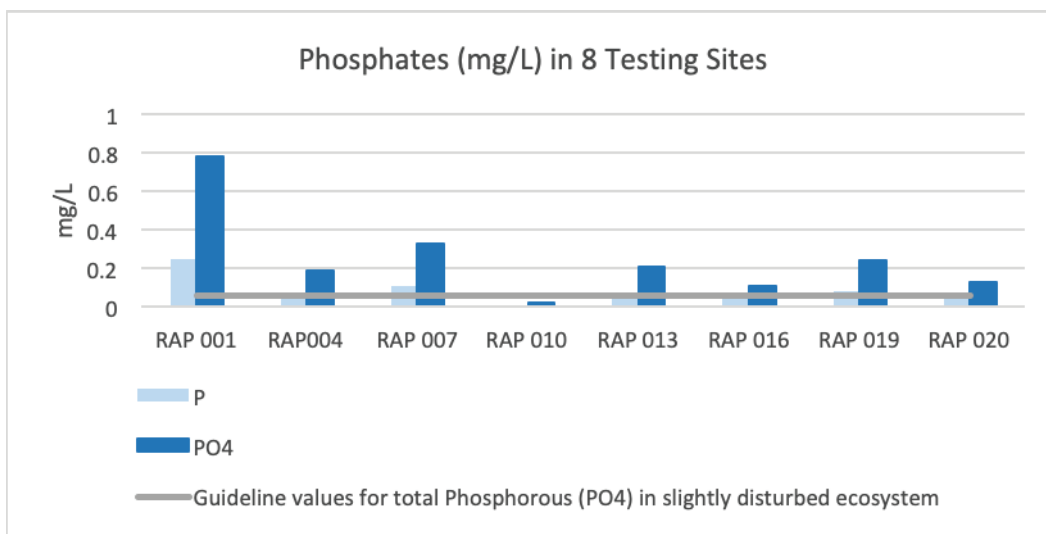
The results graphed in Figure 21 show that the concentration of phosphate at all sites, except RapCA Site 010, was above the guideline values. At RapCA Site 010, the phosphate concentration in water was well below the guideline value.

Figure 21. Phosphate concentration in 8 sites graphed against the Guideline value for total phosphorous in slightly disturbed ecosystem.

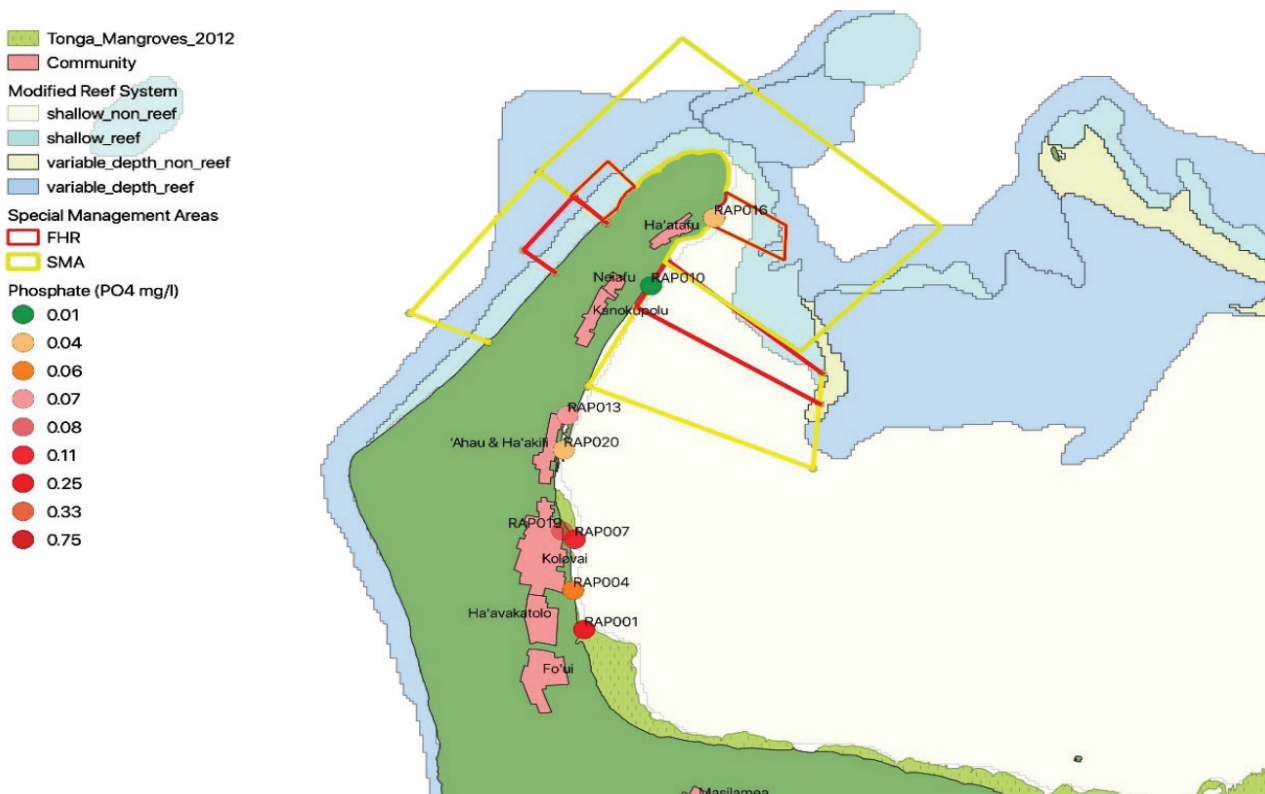
The map in Figure 22 shows that the testing sites with higher concentration of phosphates were located further inward along the coastline in areas between Fou'i and Kolovai. It can be said that these are areas that experience accumulation due to the sheltered nature and therefore these are not areas of high energy or part of the active coastal zone.

Figure 22. Phosphate (PO4) concentration across 8 sites along the Hihifo Coastline

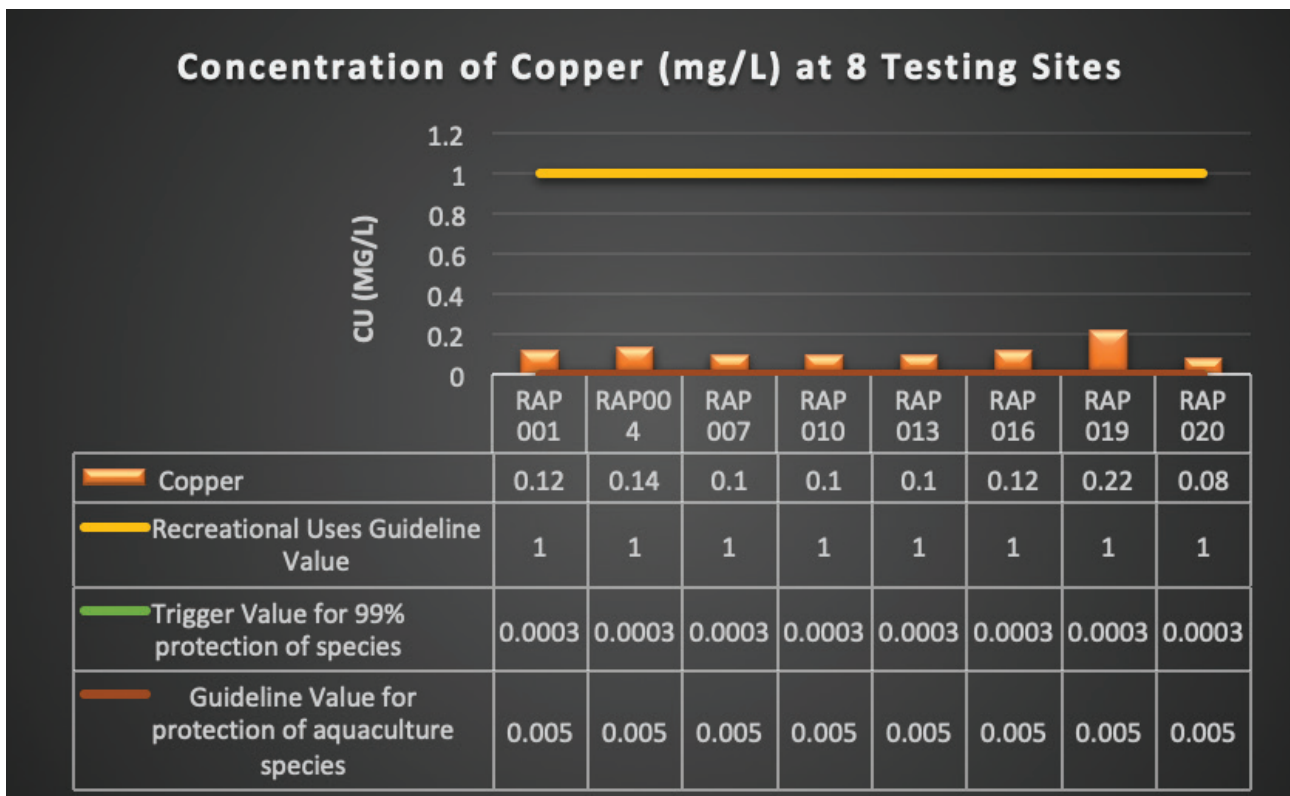
Figure 23. Concentration of Copper across 8 testing sites graphed against the recreational guideline value, the trigger value for 99% protection of species and the guideline value for protection of aquaculture species (ANZECC/ARMCANZ 2000).

Figure 23 shows that while the RapCA sites tested below the guideline value for recreational use, the concentration of copper at each site was well above the trigger value for 99% protection of species and the protection of aquaculture species.

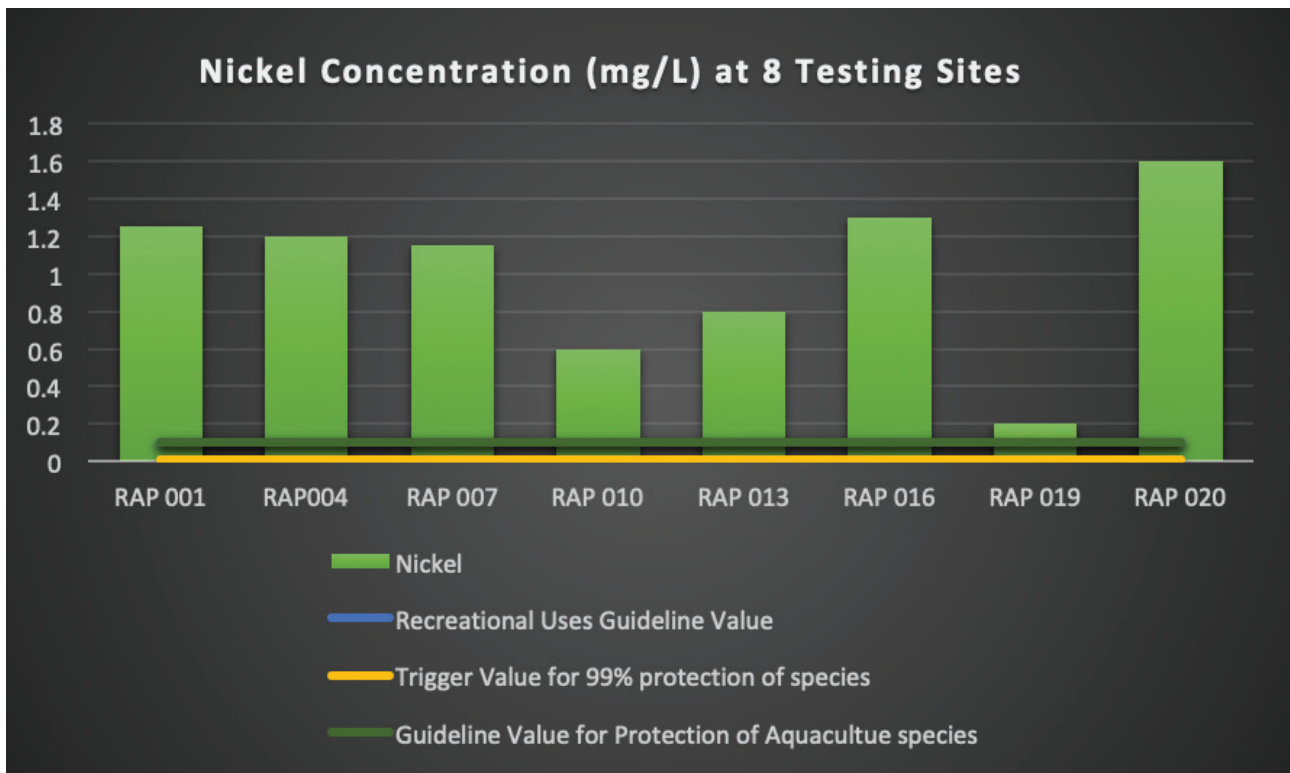
Nickel was found at all eight sites (Figure 25) with concentrations above all the three guideline values: the trigger values for 99% protection of species; specific guideline value for protection of aquaculture species; and the limit recommended for recreational uses.

Figure 25. Nickel concentration in 8 testing sites graphed against Guideline Values for 99% protection of species, protection of aquaculture species and recreational uses (ANZECC/ARMCANZ, 2000)

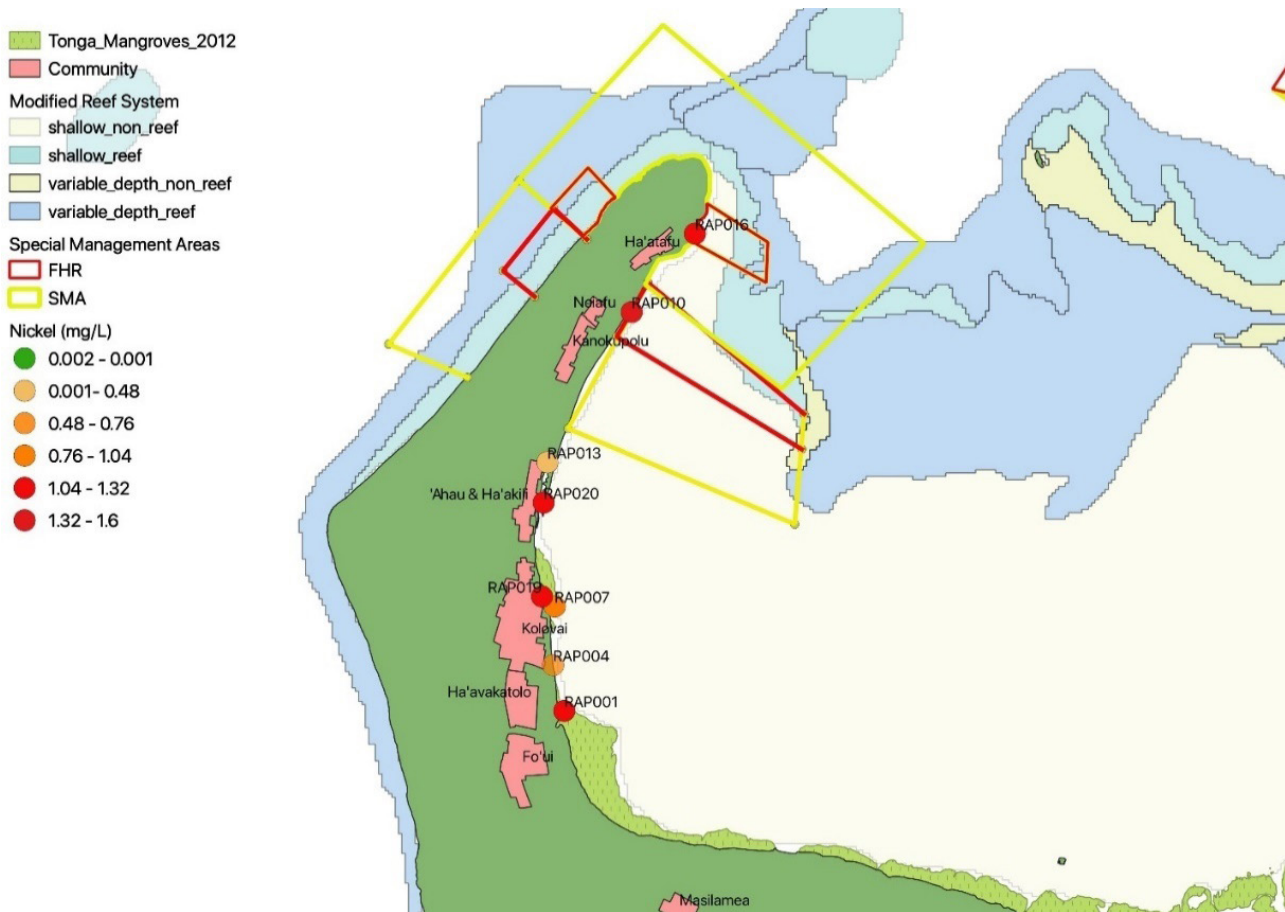
Figure 26 highlights areas of high nickel concentrations along the coastline. It is interesting to note that, in sheltered areas, such as at RapCA 013, the nickel concentration was lower than at the other testing sites.

Figure 26. Nickel Concentration mapped depicting the areas of high concentration along the coastline of Hihifo.

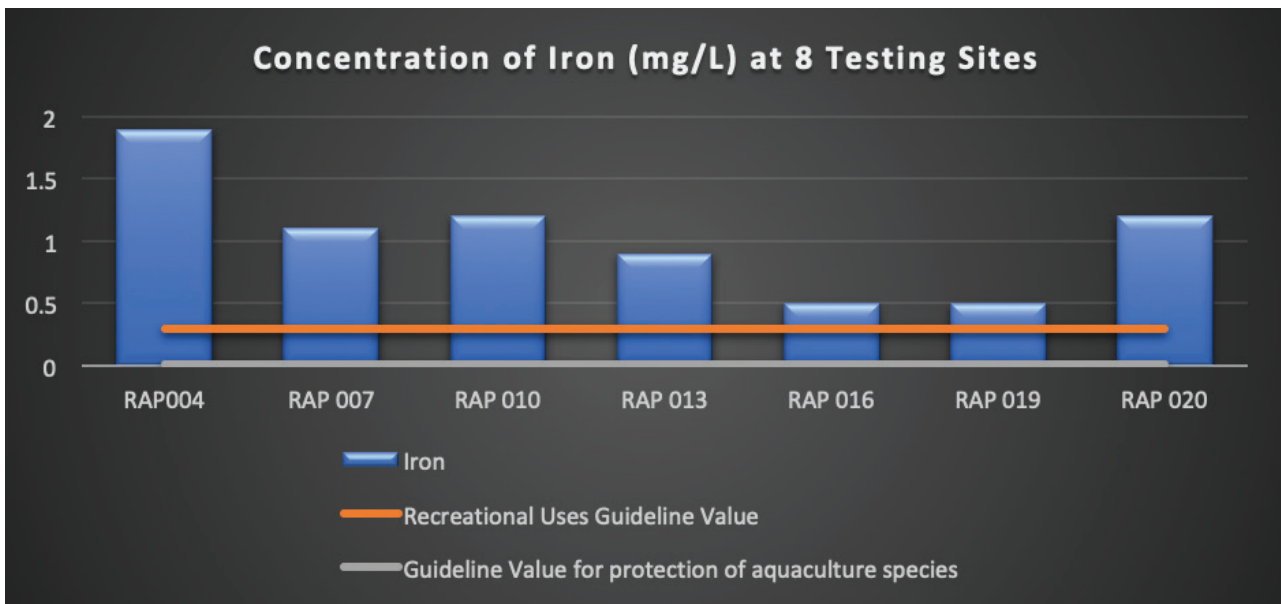
Iron concentrations in all testing sites were above the guideline values provided for both recreational uses and protection of aquaculture species (Figure 28). There is no specific guideline trigger value for protection of species at either 90%, 95% or 99% protection, which means there is no defined trigger value for protection of all aquatic species for iron concentrations in water.

Figure 28. Iron Concentration at 8 sites graphed against Guideline values for Recreational Uses and Protection of Aquaculture species (ANZECC/ARMCANZ 2000)

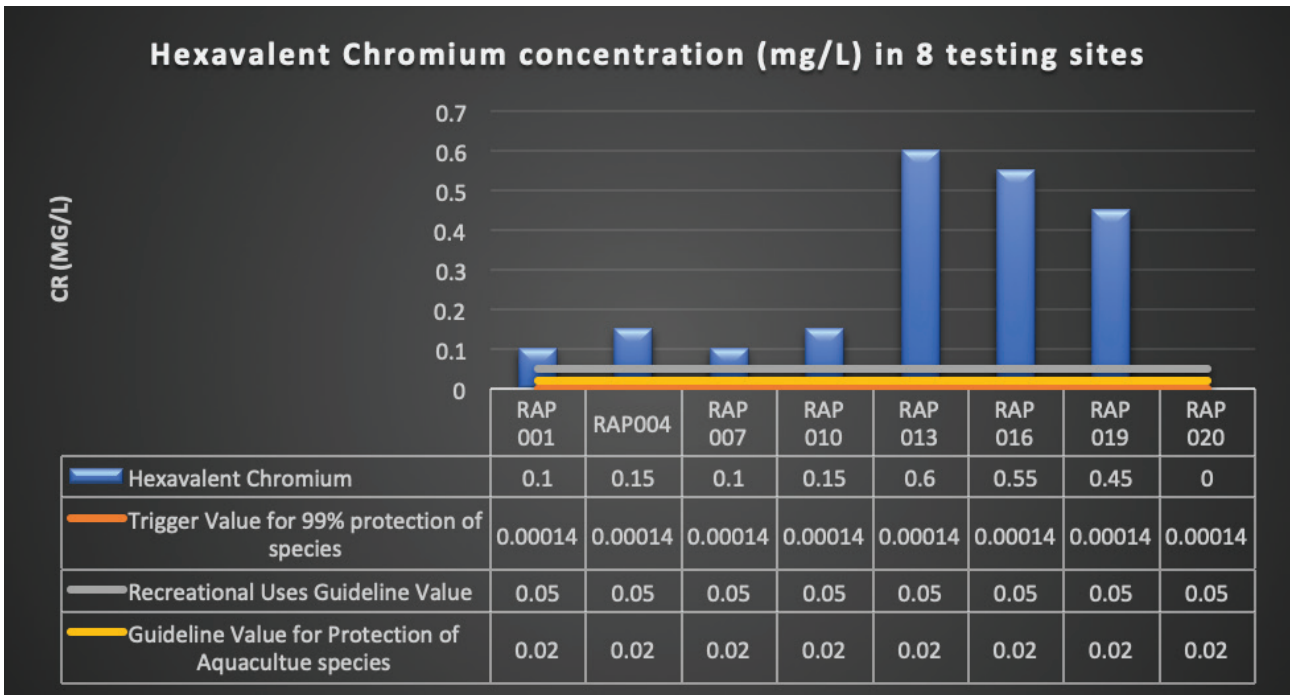
Hexavalent chromium concentrations at all testing sites were found to be above the guideline values provided except for RapCA Site 020, which recorded 0 concentration of hexavalent chromium. This is an interesting find as RapCA 020 is an additional site requested to confirm and assess the extent of pollution seen in this area. Another point of interest is RapCA site 013, which was a site showing one of the least amounts of nickel but had the highest concentration of hexavalent chromium (Figure 29).

Figure 29. Hexavalent chromium concentration at 8 sites graphed against Guideline values for 99% protection of species, protection of Aquaculture species and Recreational uses (ANZECC/ARMCANZ 2000).

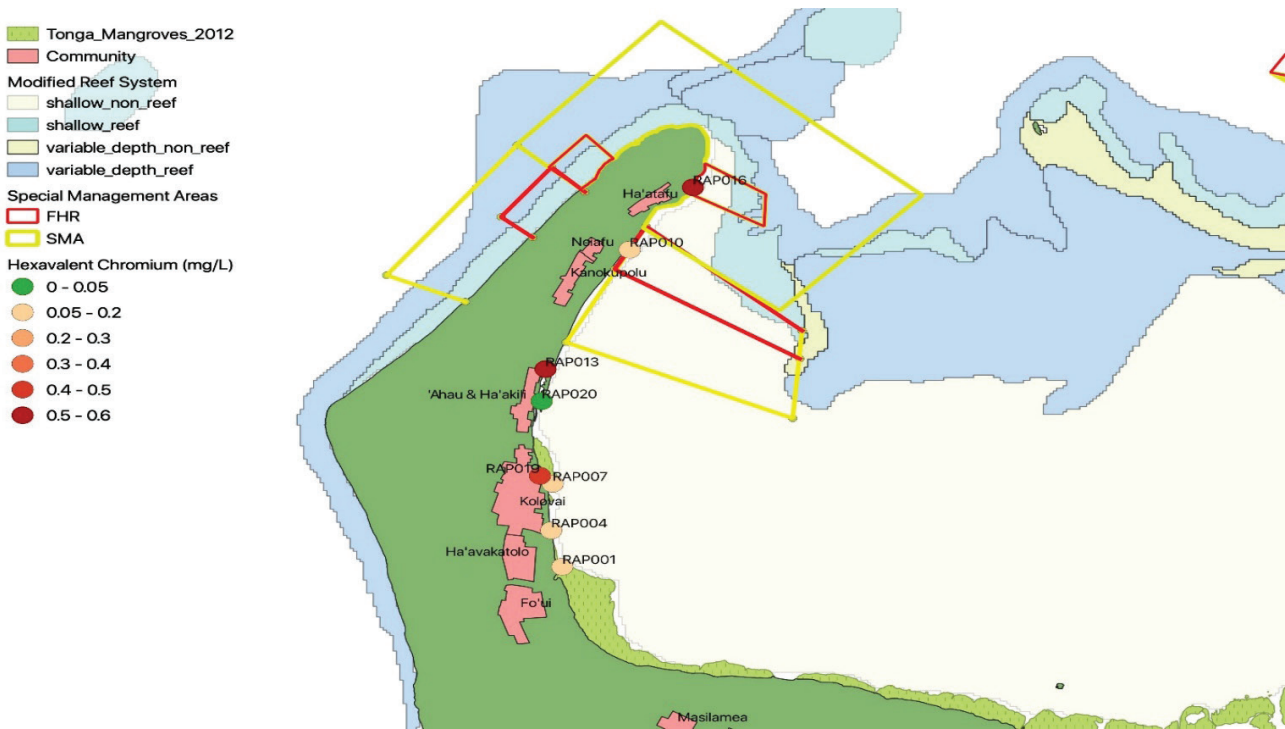
Figure 30. Hexavalent chromium concentration mapped to show areas of high concentration along the coastline of Hihifo.

Figure 30 depicts the hexavalent chromium concentration along the coastline of Hihifo. Note RapCA Site 016 and 013 where the highest concentration of hexavalent chromium was found.

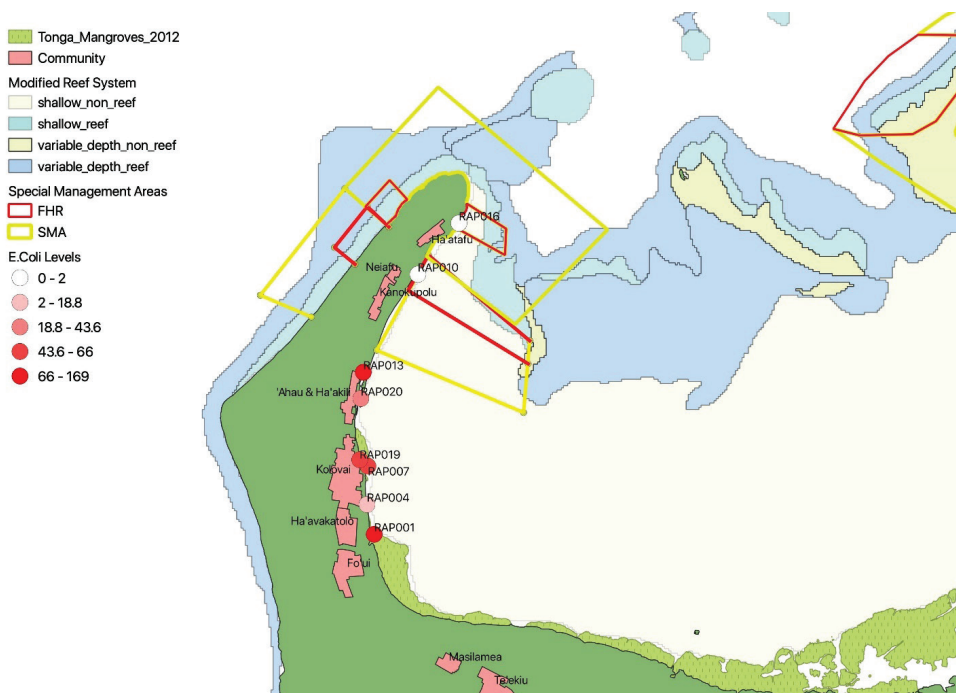
Figure 32 explains the results. The two sites that tested below the guideline values are areas of high current movement and part of the active coastal zone. Any form of pollution would be easily dispersed with the turning of the tides. The remainder of the sites are located further in the arm of the peninsula and are sheltered by the mudflats of the lagoon. These are not areas of high energy or current/tide movement (not part of the active coastal zone) and the pollution seen in these areas is not easily dispersed and more likely to accumulate due to the tides slowly bringing in pollutants from other areas in the lagoon.

Figure 32: Mapping of Faecal Coliform results along the Hihifo coastline to show areas of high concentration
