Federated States of Micronesia (FSM) International Waters Ridge to Reef Project

Tofol Watershed Catchment Geological Assessment from Ridge to Reef, Kosrae State, FSM

Prepared by Dr. Nick Zoa
(Freelance consultant; nick@zoa.com)

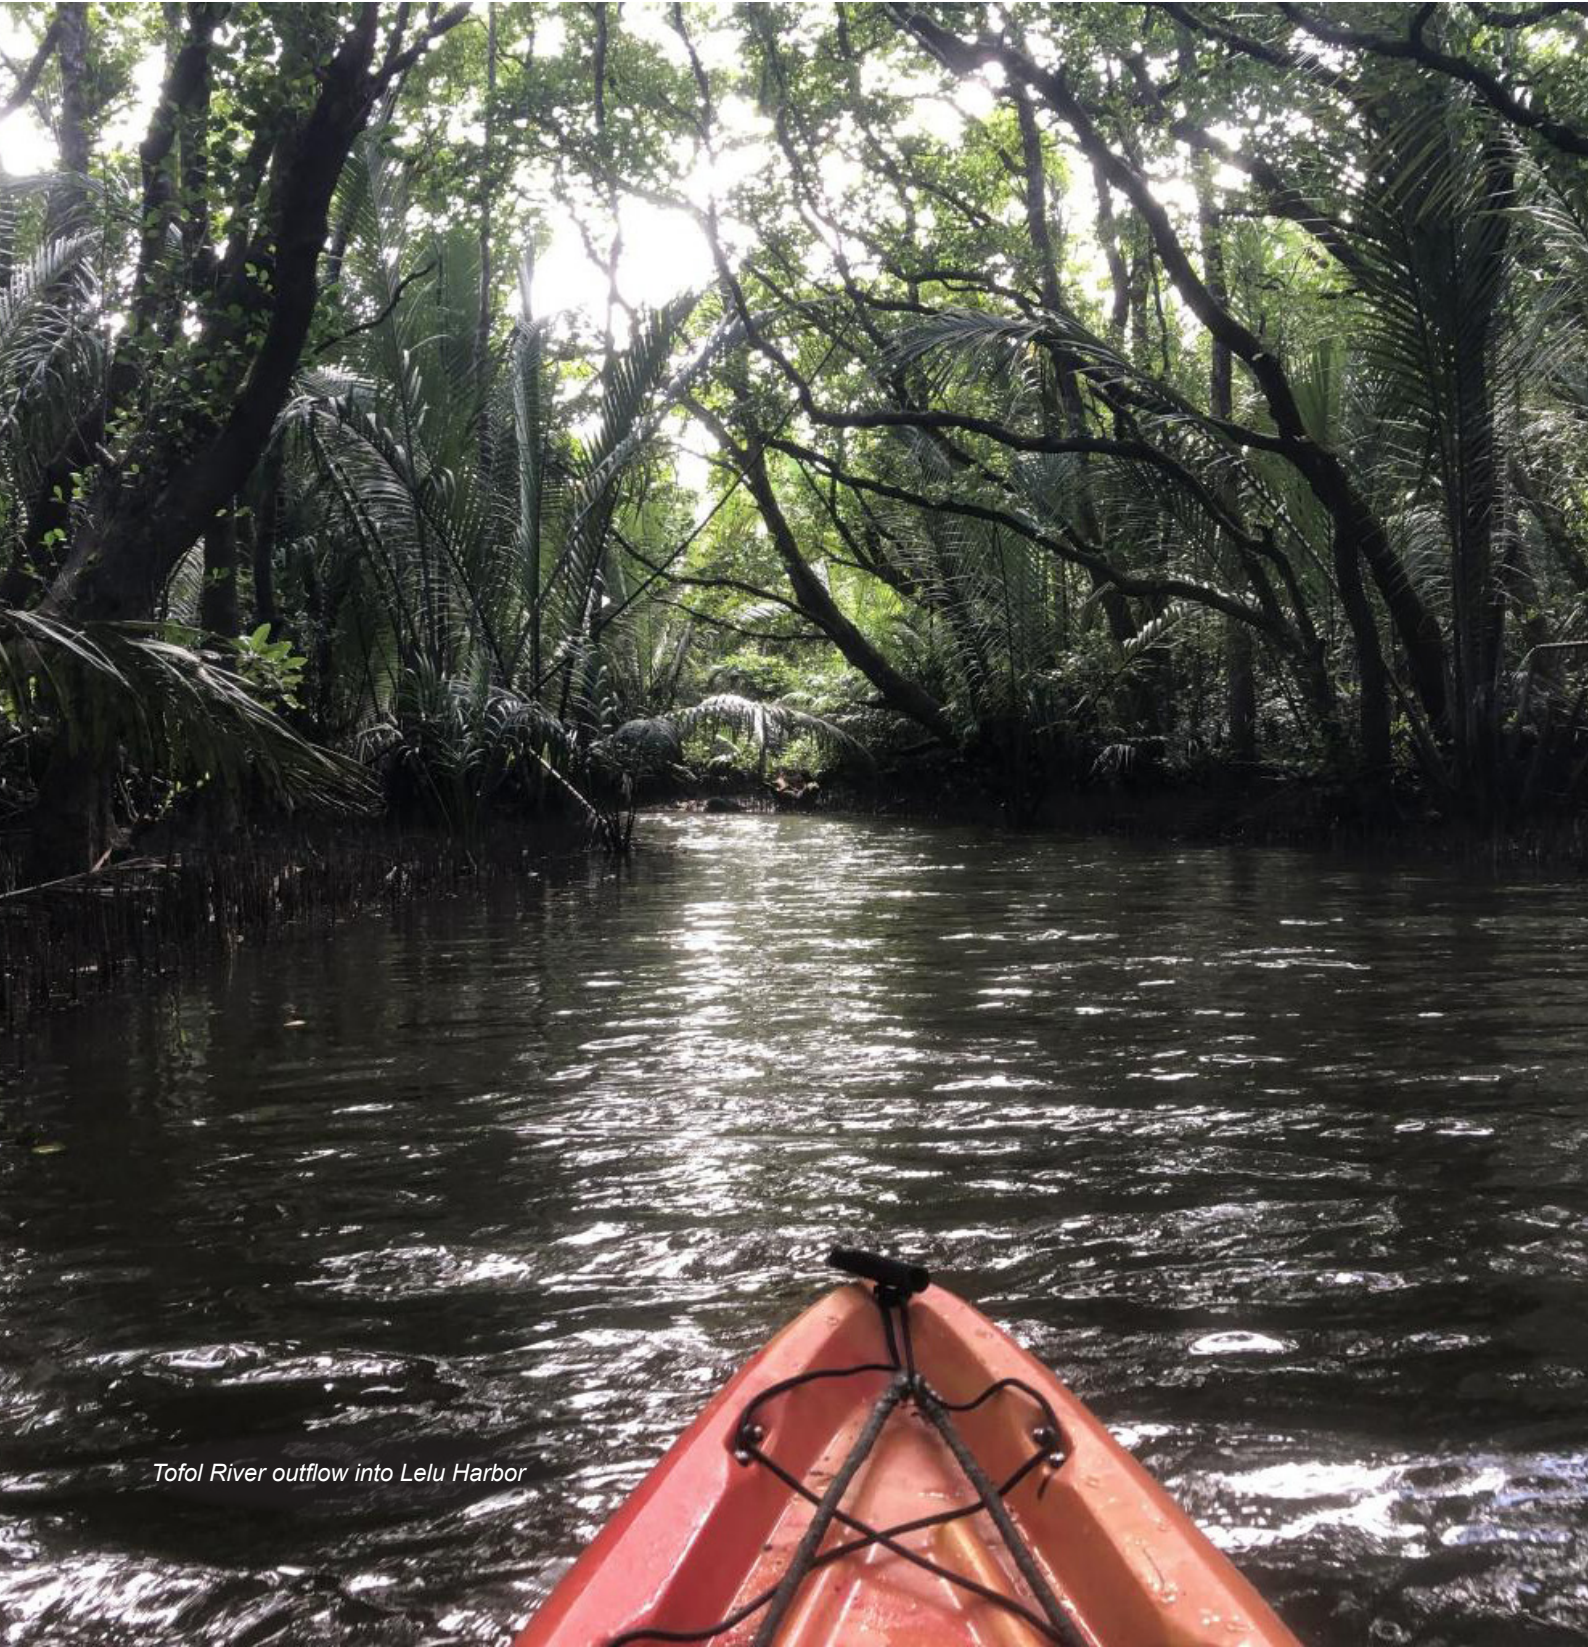
Tofol River outflow into Lelu Harbor

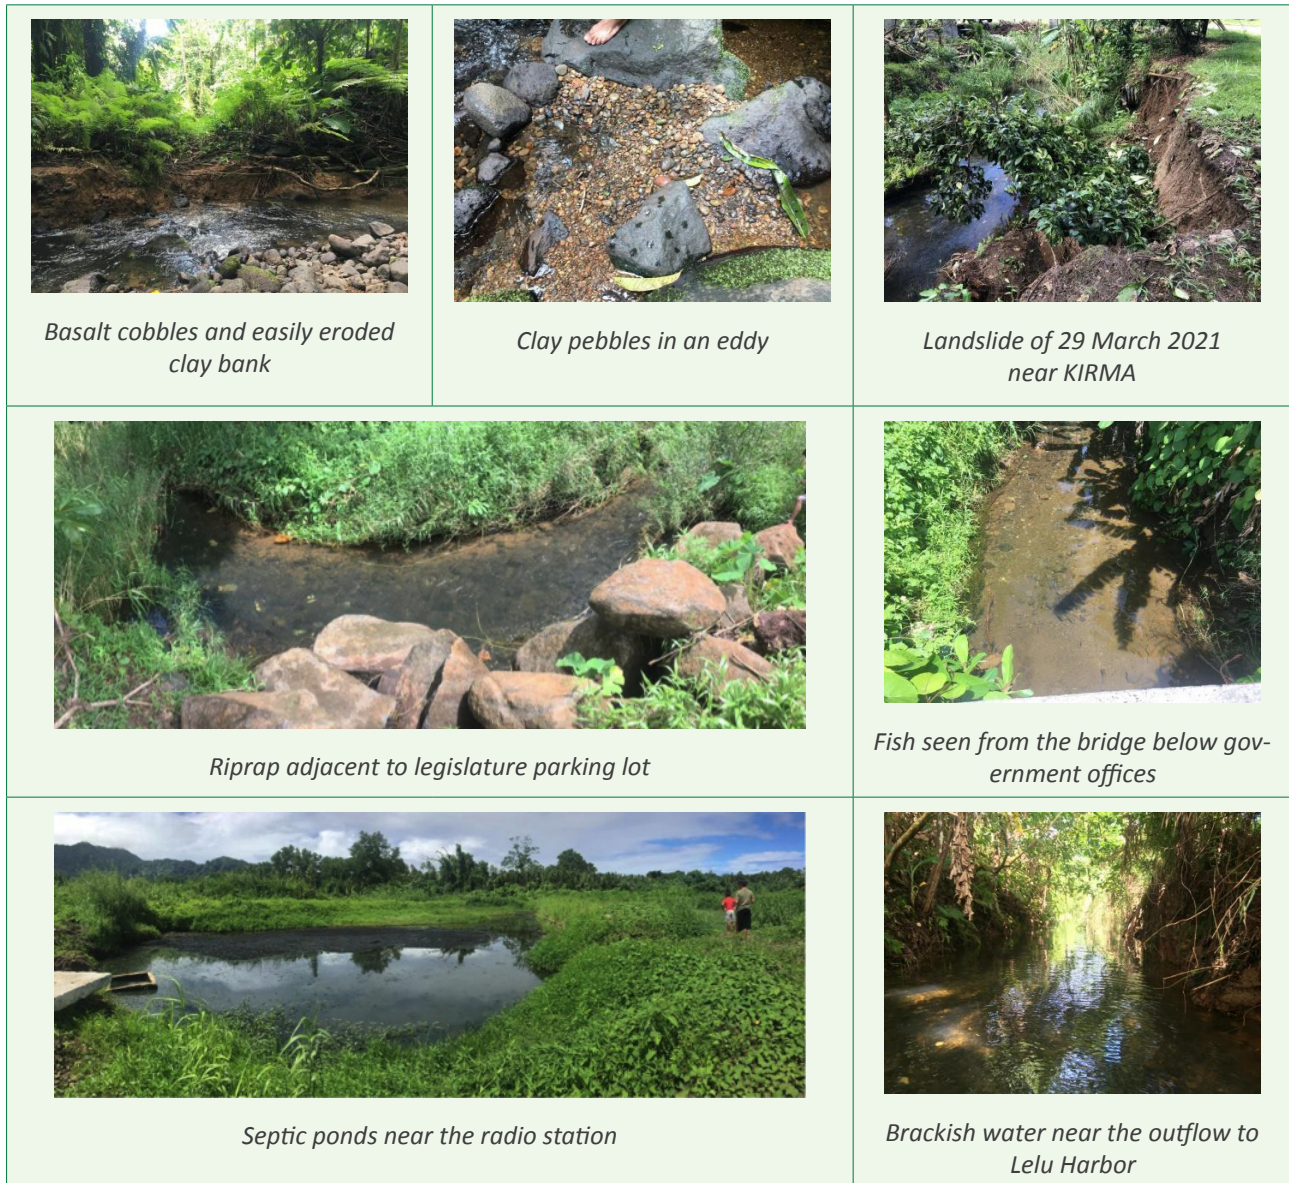
Figure 1: Tofol river notable observations

Tofol river was found to be slightly silted but clear enough to see pebbles on the riverbed due to the observation of no construction, no buildings, and no agricultural activity upstream. Other observations of note were river water had a milky quality where a vehicle scrap yard and septic fields were in close vicinity. However, due to the incoming high tide, the milky quality observed may have been due to coral silt entering the river channel.

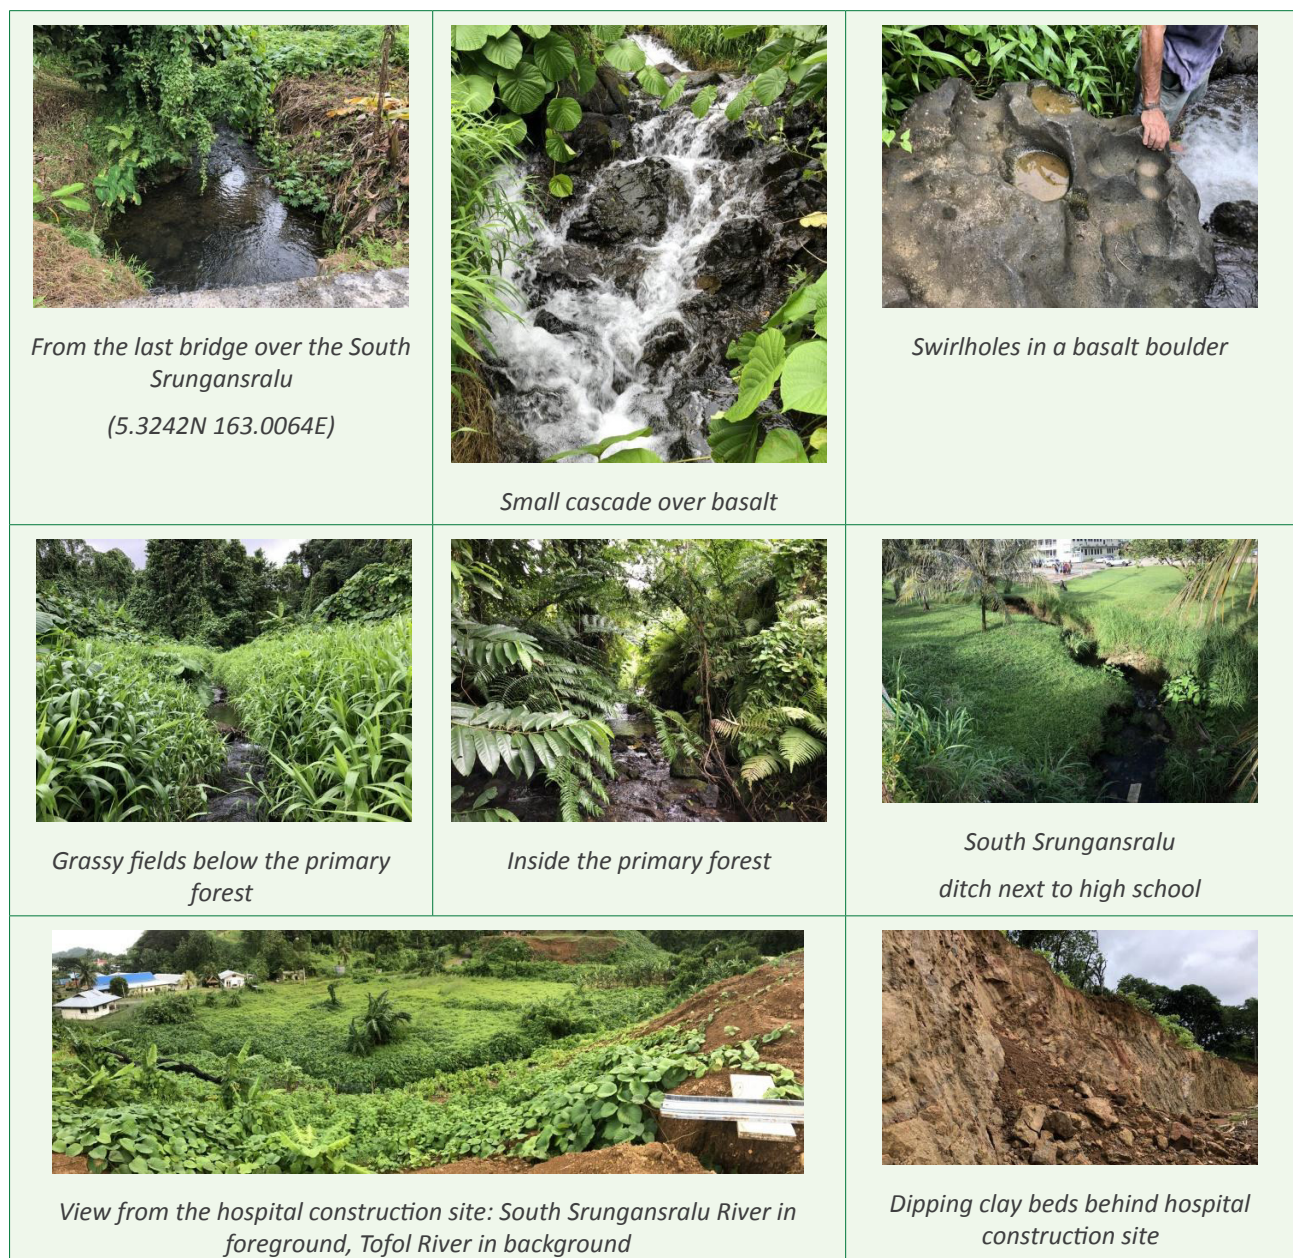
Figure 2: Srungansralu river notable observations

It was suggested that there are bedded clays dipping to the southwest as also observed in Tofol river. This suggested that an uplift occurred to the northeast in the distant past. Tilted clay beds could be found in Innem that were similar to Tofol riverbanks as well.

Downstream from the primary forest, the South Srungansralu flows through a grassy meadow where sand and gravel have created swirlholes in the basalt boulders in mid-stream. During times of heavy rain, silt from the hospital construction site contaminates this stream and is carried to the alluvial marsh downstream.

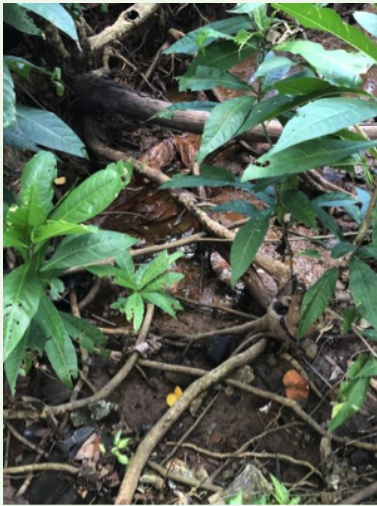
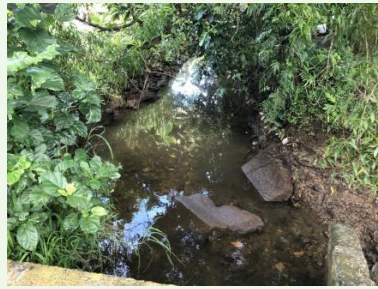
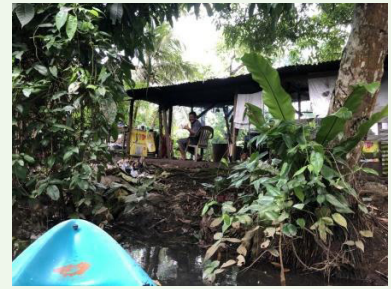
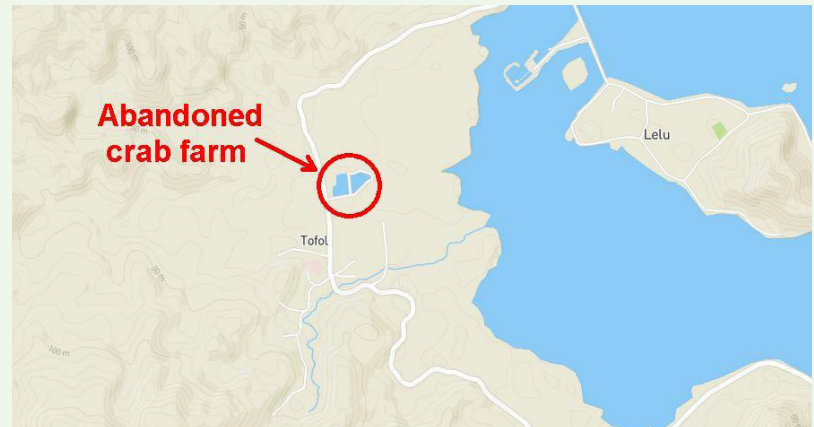
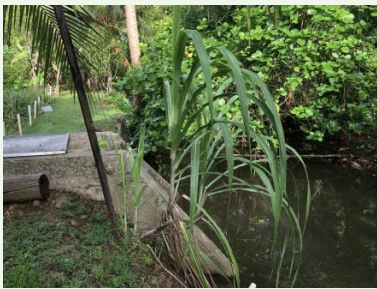
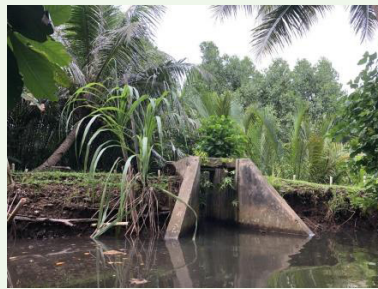
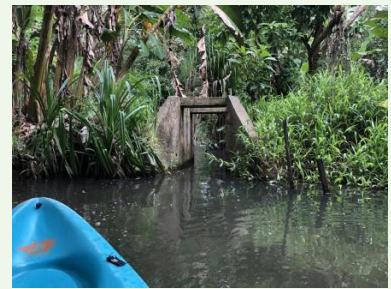
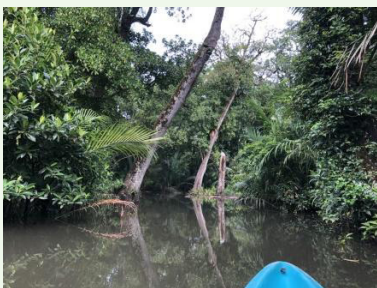
Figure 4: Srungansralu Channel observations

*Small spring at the start of the channel
(5.3292N 163.0080E)*

View of the channel from the main road

Location of former crab farm enclosures

Western sluice gate with channel to the right

The western sluice viewed from the channel

The eastern sluice viewed from inside the enclosure

The salt marsh of the Srungansralu

The exit of the Srungansralu River into Lelu Harbor

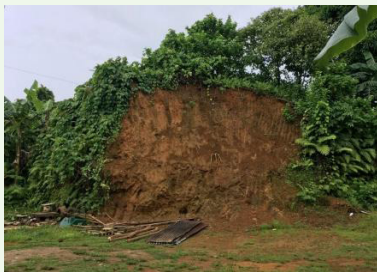
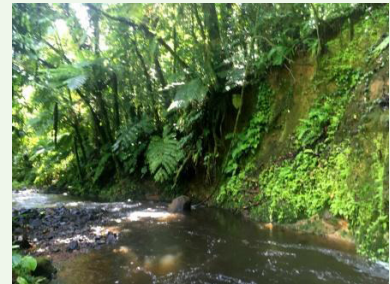
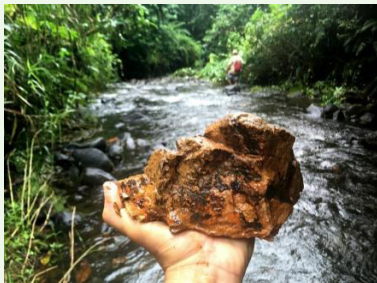
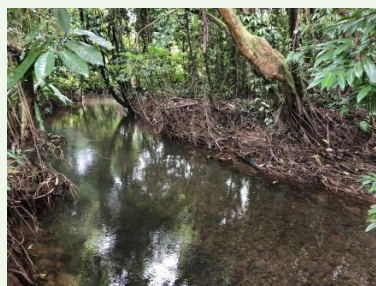
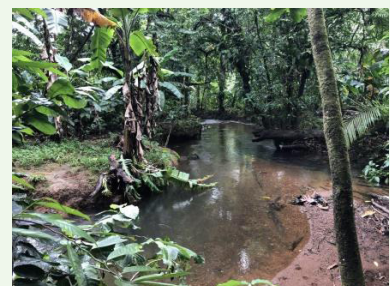
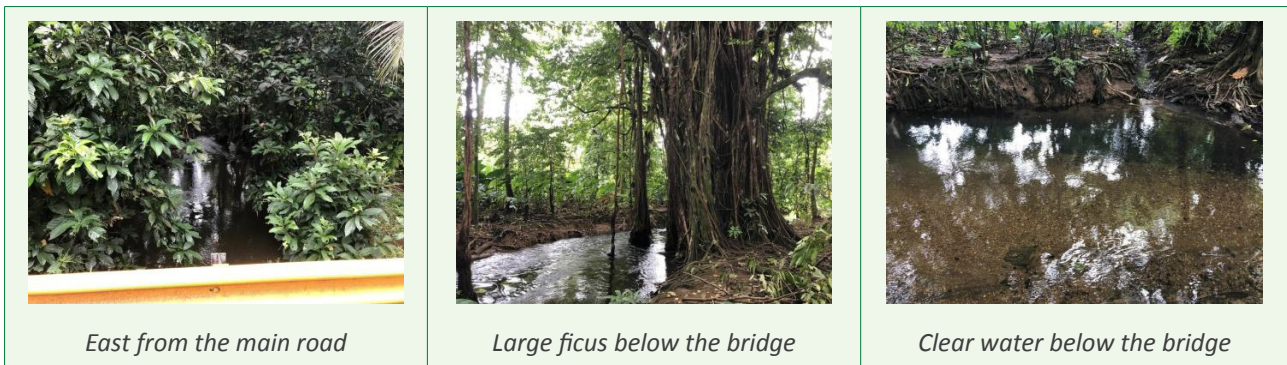
Figure 5: Innem River observations

The Innem river was accessible by foot, and a farm road along the north side of the river allowed access to homes and farms. Clay deposits form the walls of the Innem Valley. Innem river consists of dendritic streams and creeks flowing down steep ravines through undeveloped forests.

Unlike the North Srugansralu on the south side of the Innem Valley, the Innem river remained clean and clear down to the bridge on the main road. This is due to five reasons:

Road cut showing clay walls of the Innem Valley

At 5.3280N 162.9980E, the Innem river is 10m wide.

Vertical clay riverbanks

Clay from riverbank

Red clay cobble

Calm section near road

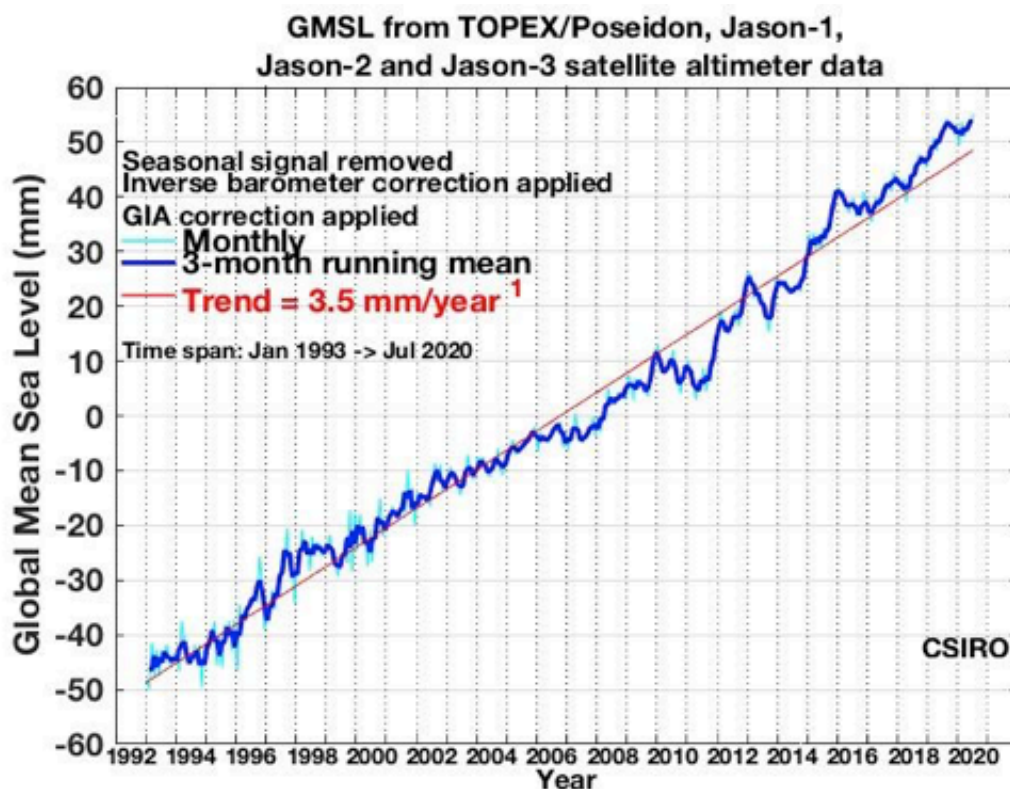
Figure 7: Global Mean Sea Level from the year 1992 to 2019

For the past 30 years, the Global Mean Sea Level (GMSL) has risen at an average rate of 3.5 mm/year. For the next 30 years, the rise of the GMSL is predicted to accelerate to at least 1 cm/year. By the year 2050, the mean sea level of Lelu Harbor will be 30 cm higher than its current level, or higher.

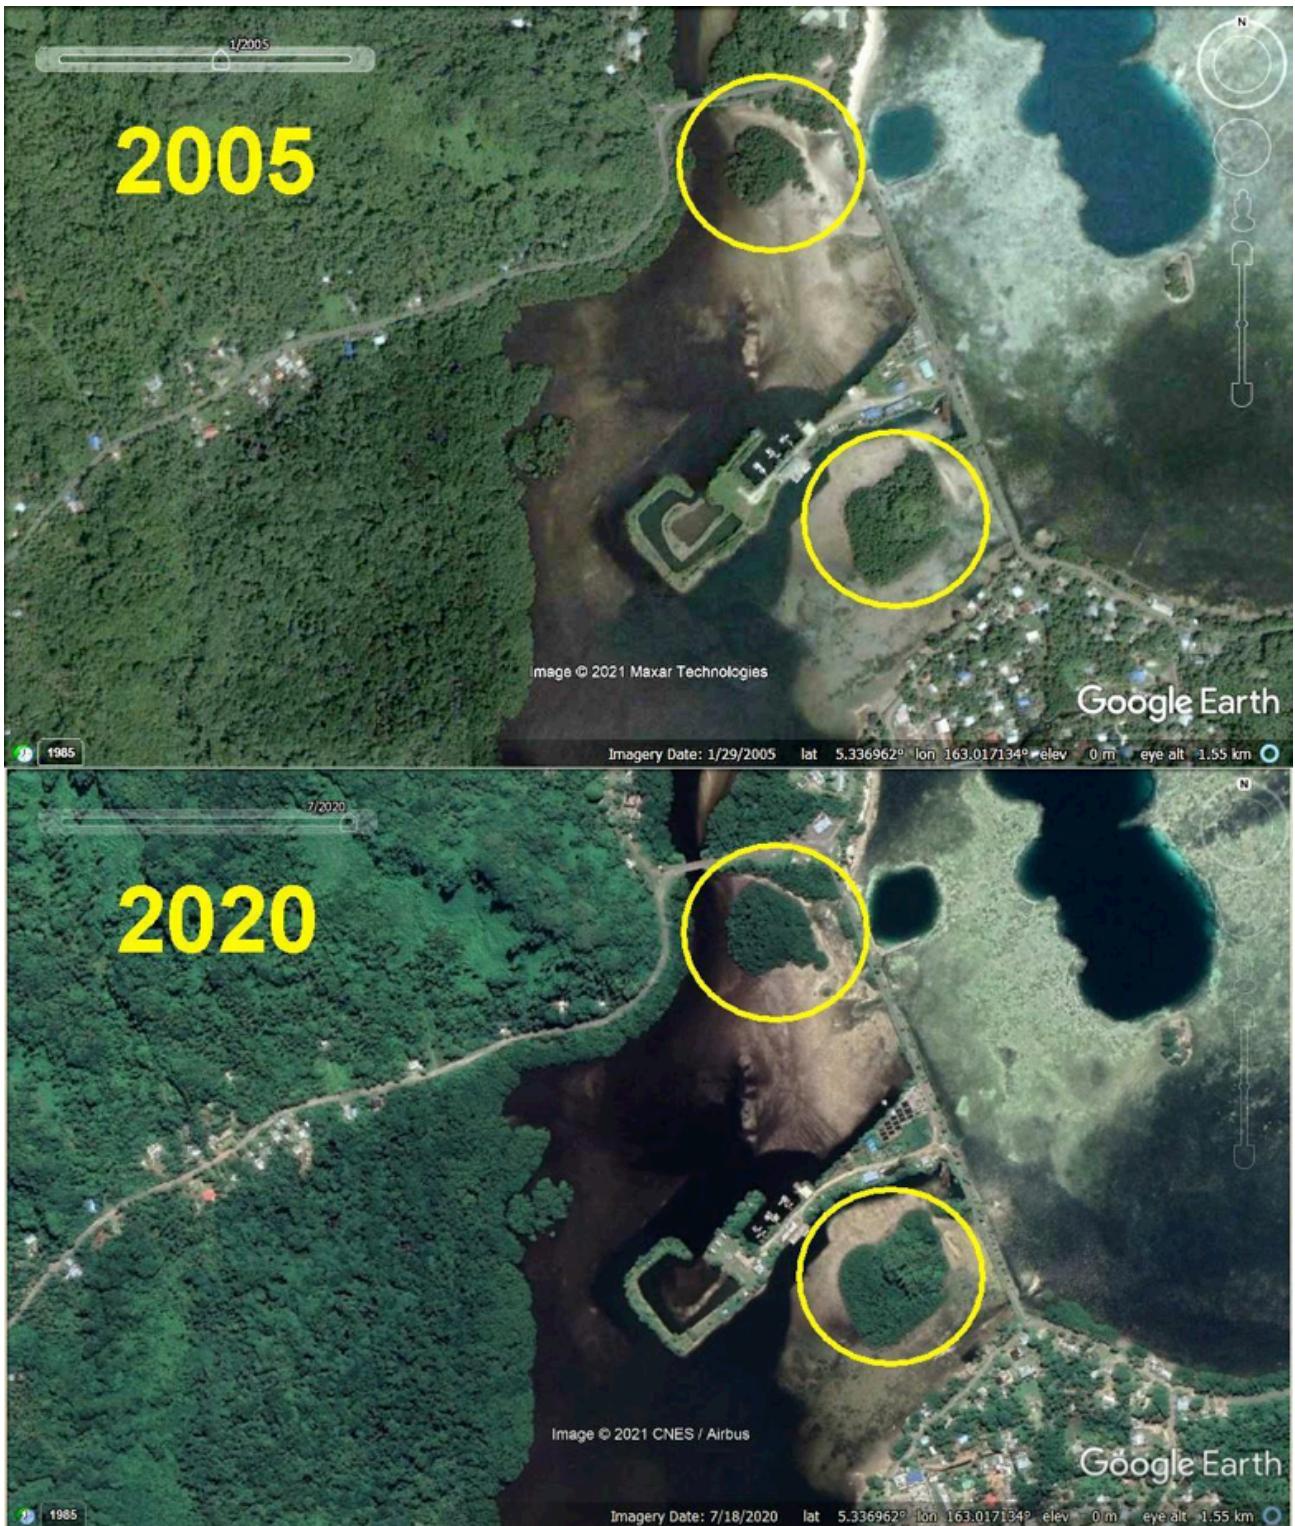
Figure 8: Aerial photos of the LMPA showing expansion of mangroves near the Lelu Causeway from 2005 to 2020

Another negative impact of heavy sediment discharged from the Tofol Watershed was the silting-in of Lelu Harbor. Satellite photos of the LMPA taken on 29 January 2005 and on 18 July 2020 that were published on Google Earth were compared. These photographs showed substantial expansion of mangroves near the Lelu Causeway. The expansion of the mangroves occurred because the water near the Lelu Causeway was shallower in the present day than it was 15 years ago. During the past 15 years, Global Mean Sea Level had risen at a rate of 3.5 mm/year. If the mangrove forests near the Lelu Causeway were expanding, then Lelu Harbor was silting-in faster than the sea was rising. It was estimated that the rate of in-fill of the Lelu Harbor by sediment discharge was greater than 3.5 mm/year.

- D. Recycle or properly dispose of all non-biodegradable garbage.
2. The Lelu Causeway prevents semidiurnal tidal flushing of Lelu Harbor.
 - A. The Lelu Causeway should be replaced with a series of bridges with wide, deep channels between bridge supports. This will allow strong tidal currents to flow in and out of Lelu Harbor, flushing sediment, pollution, and garbage into the open sea.

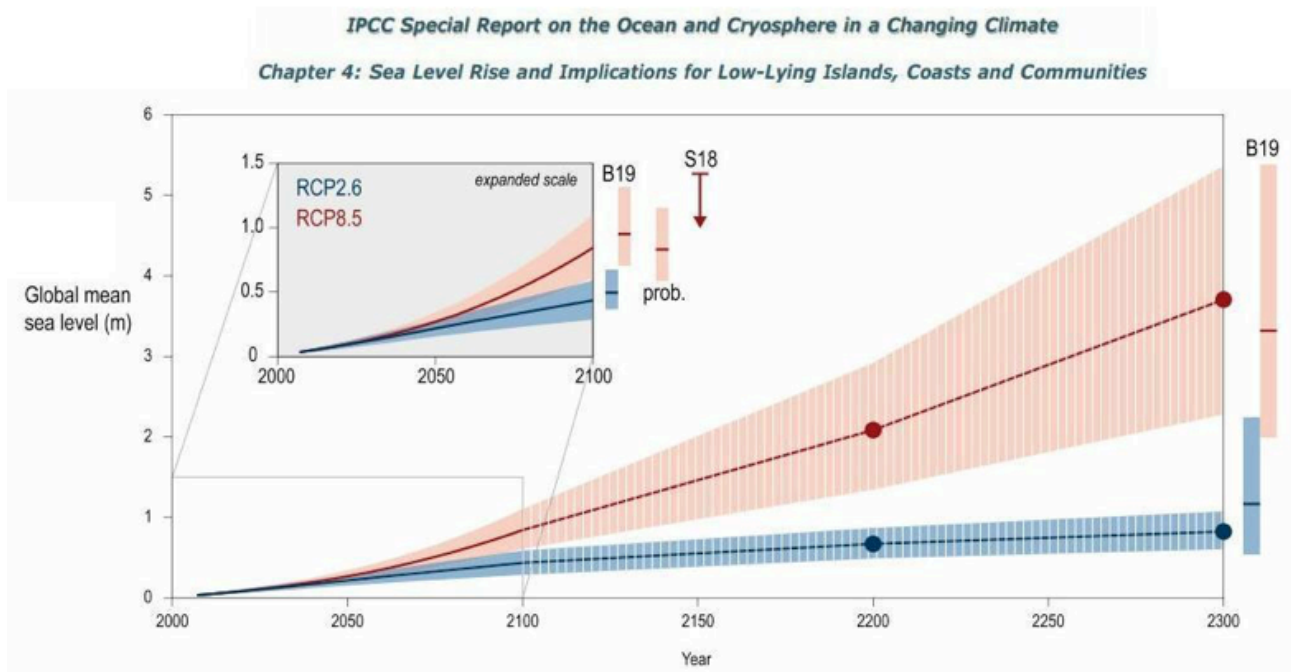
Figure 10: Future global mean sea level projections till the year 2300.

As a result of this rise in sea level, the freshwater and brackish marshes near the mouths of the Srungansralu and Innem rivers will become saltwater estuaries by 2050. The soft, muddy sediments along the banks of these three rivers will erode rapidly and wash into the LMPA where they will add to the in-filling of Lelu Harbor.

3. Preparations for rising seas in 2050 should begin now.
 - A. No new construction should be approved east of the paved road.
 - B. The septic fields east of the high school should no longer be used. If the septic fields are left fallow for a few decades, they will lose most of their toxicity and not poison the harbour when they flood with rising sea levels.
 - C. Damaged vehicles should no longer be abandoned in the area immediately north of the radio station. This will prevent toxic materials from old cars from leaching into Lelu Harbor when sea levels rise.
