KIRIBATI INTERNATIONAL WATERS RIDGE TO REEF PROJECT WATER QUALITY TRAINING WORKSHOP REPORT

May 2020

Prepared by
Samasoni Sauni | Iliana Marama | Teema Biko

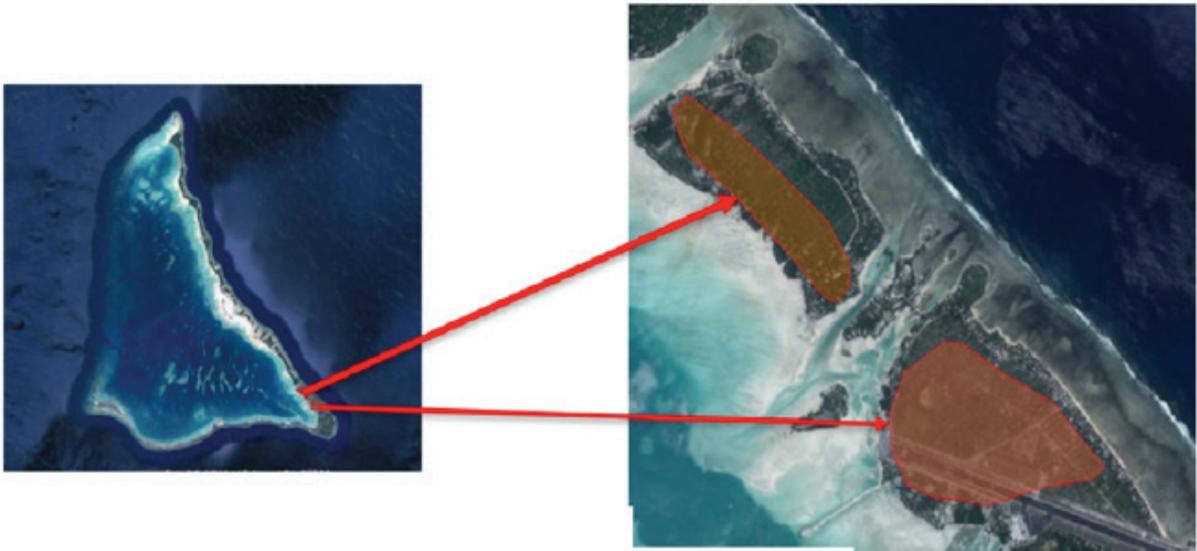
Figure 1. Kiribati IW R2R Demonstration Sites in South Tarawa – the shaded areas are roughly the boundaries of Bonriki & Buota Water Reserves

The Kiribati IW R2R demonstration sites are Bonriki and Buota Water Reserves, and the former is the largest and the main source of freshwater for an ever- increasing population currently at around 50,182 people living in South Tarawa. Bonriki water reserve is a small, 0.7 km, but important aquifer for the country with most of the population residing in South Tarawa. Figure 1 & 2 below depict the two water reserves showing the boundaries, and features of galleries, monitoring bores, PUB⁴ treatment plant and wetlands.

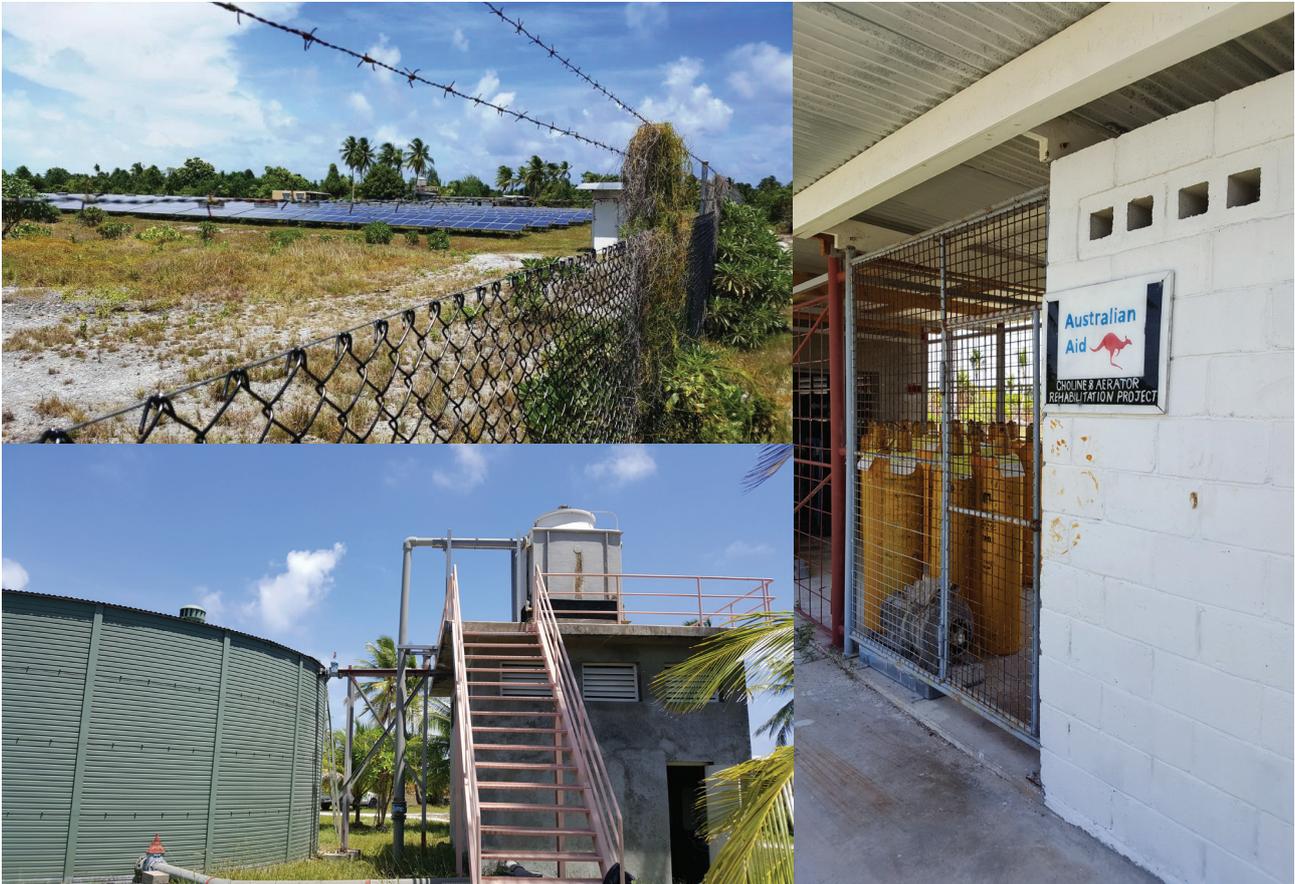
Figure 3. PUB Water Treatment and Storage Facility located in the Bonriki Water Reserve.

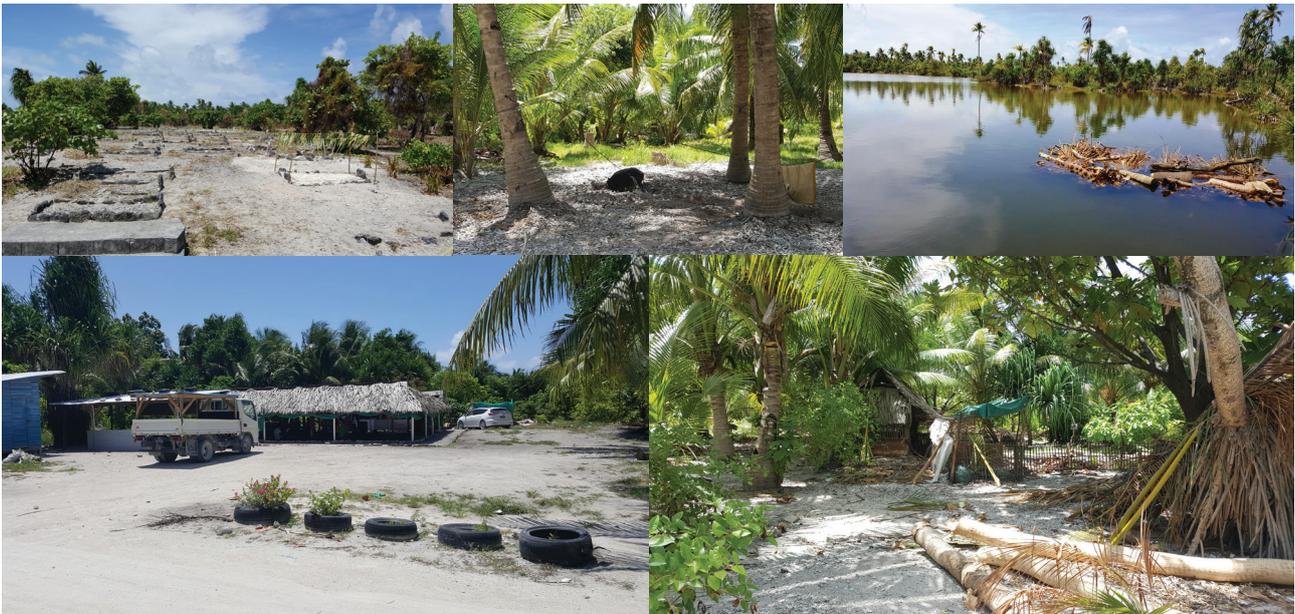
Figure 4. Land-use activities in the Water Reserves contributing to water contamination and degraded coastal ecosystems (cemetery, fishponds, stray pigs, squatters)

Like other areas in the Pacific, the Bonriki water reserve is subject to impacts from reduced recharge from drought and overtopping from storm surges, causing water quality impacts, which in some cases can make the water unusable for its intended purpose. Figure 4 shows several land-use activities contributing to water quality contamination.

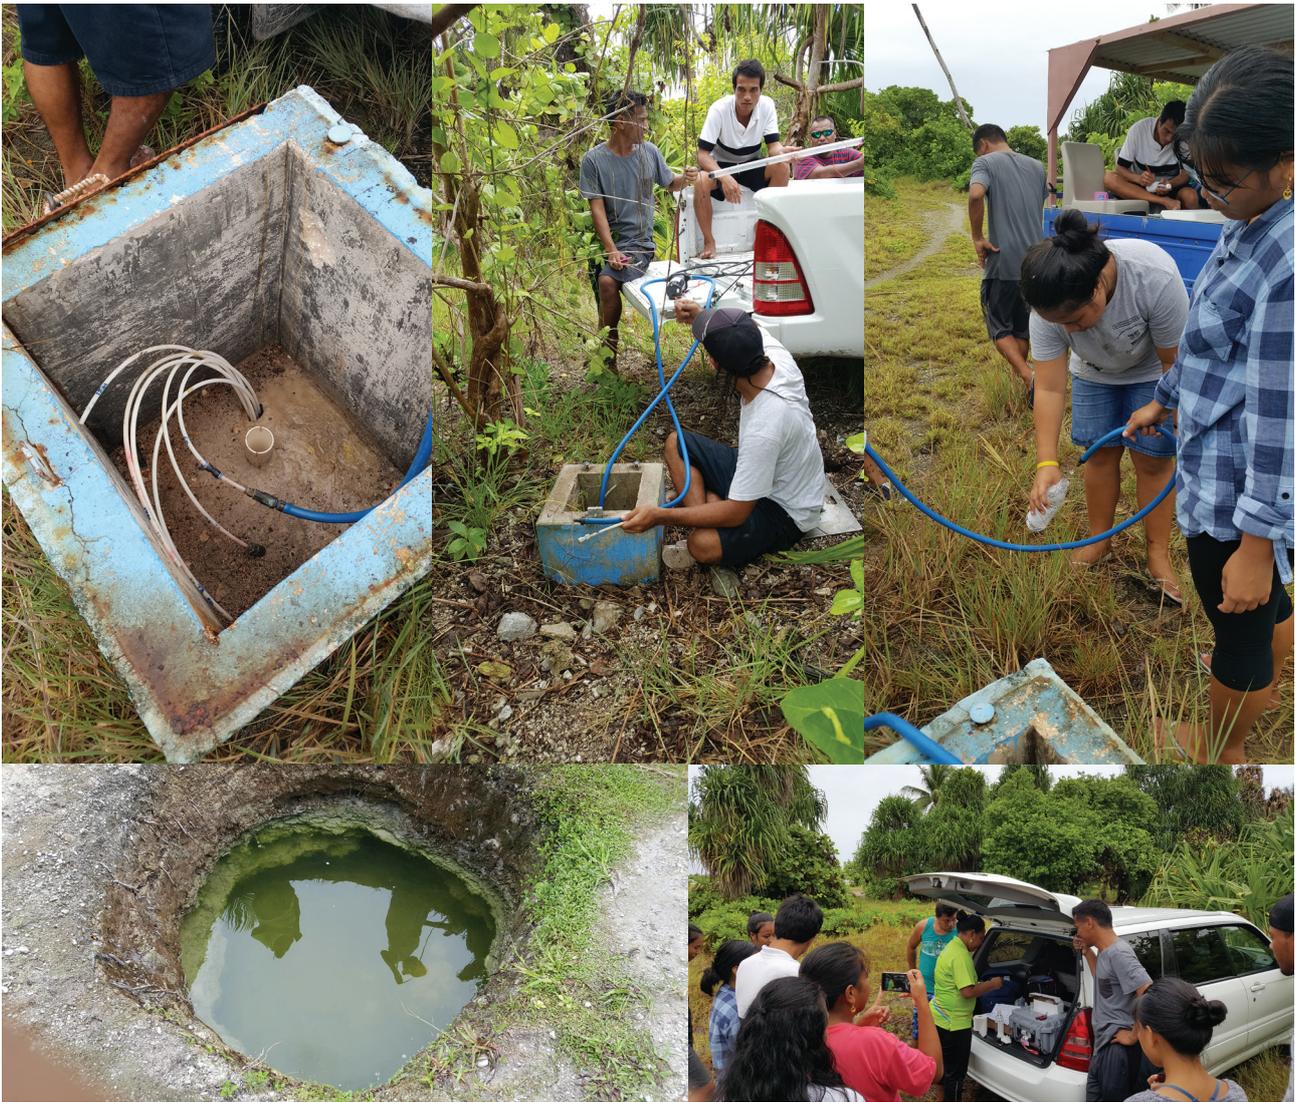
Figure 5. Showing concrete platforms of boreholes with plastic water tubes coming through concrete surface, which are used to extract water from different depths.

In the reserve, the installation and use of variable pumps are used to optimise water abstraction while maintaining water quality. However, for purposes of monitoring water quality, concrete platforms are set at the top of each borehole with plastic water tubes coming through concrete surface, which are used to extract water from different depths. Each tube represents one depth. Using different connectors, a rubber water pipe is connected to the a 'depth pipe' one end and the end connects to a battery-powered water pump which then connects to another water piping to fill sample bottles. The details are clearly shown in Figure 5 below.
