Yap Island

Coastal Degradation Assessment Report

**Developed for UNDP GEF 5
Ridge to Reef Project**

September 29, 2017

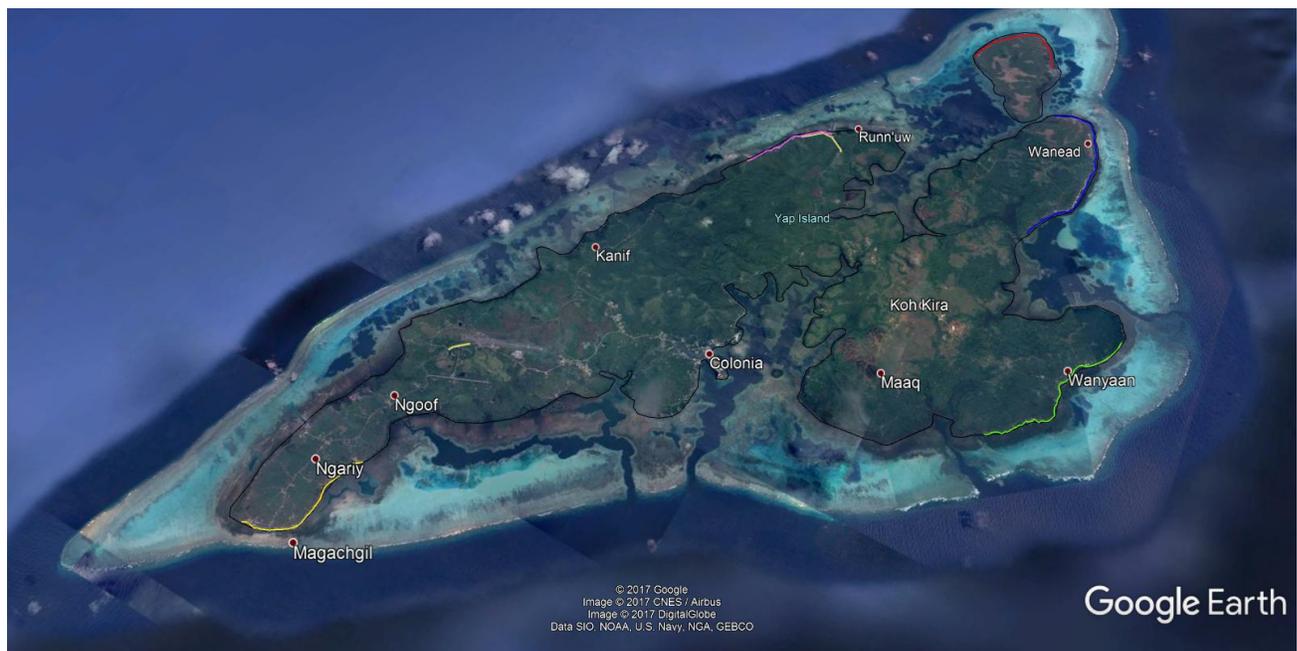
During the survey 100 percent of the 58 miles of the main island's coastline was covered and visited. Eroded areas are at an estimated 22% or 13 miles. Most of these affected areas are found on the northern and western parts of the island, namely, Gagil, Maap, Rumung, and Fanif. Gilman is on the southern eastern part of the island. Rull however is on the south-eastern part of the island. Refer to below map for better orientation as well as locating the eroded and affected areas.

Green colored coastal outlines represent the affected areas in Gagil. The *blue* colored coastal outlines represent the affected areas in Maap. The *red* colored coastal outlines represent the affected areas in Rumung. The *pink* colored coastal outlines represent the affected areas in Fanif. The *yellow* colored coastal outlines represent the affected areas in Gilman and Rull.
