AN ASSESSMENT OF WATER QUALITY AND BIODIVERSITY OF THE MATANIKO CATCHMENT, SOLOMON ISLANDS

Prepared by Robson Hevalao

Produced by GEF Pacific International Waters Ridge to Reef Regional Project, Pacific Community (SPC), Suva, Fiji

Suva, Fiji, 2021

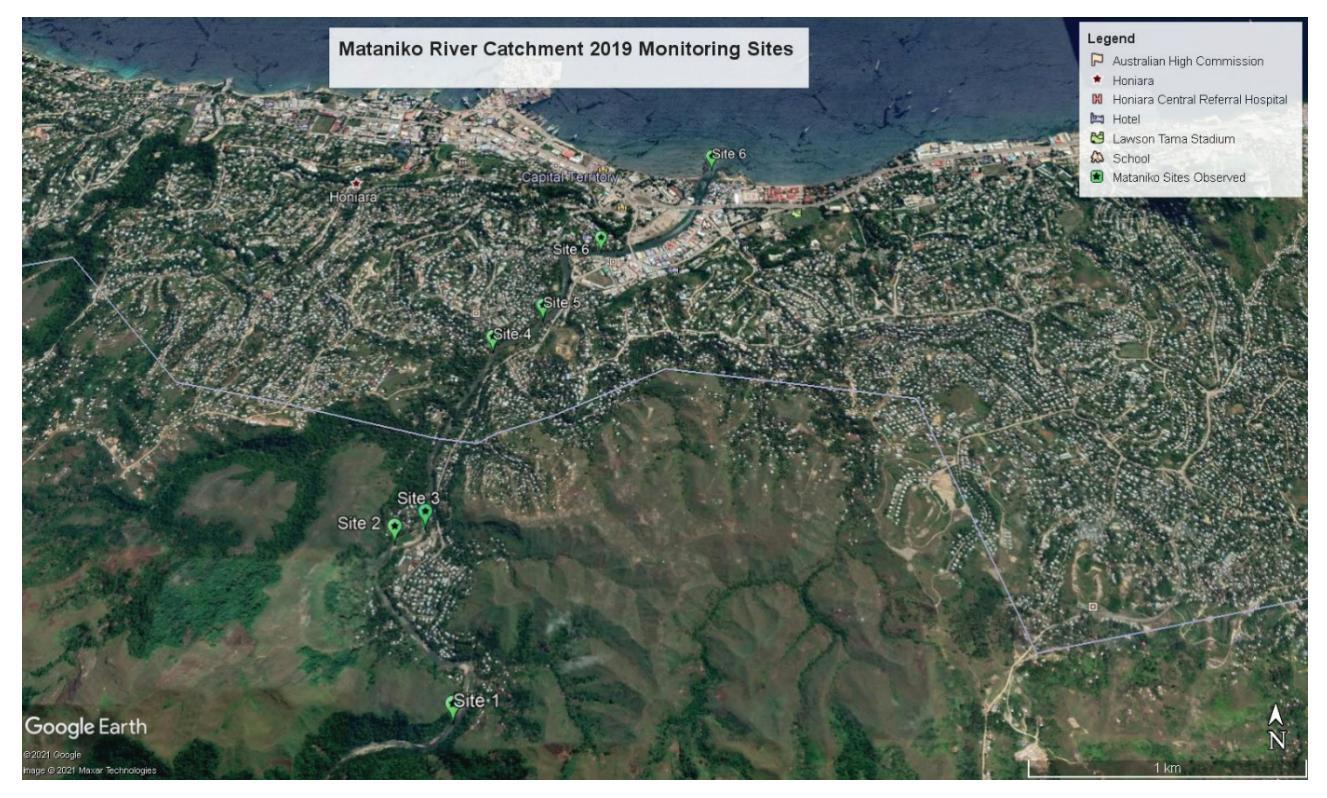
Figure 1 shows the sites observed and sampled in 2019 by the MECDM

Figure 1 clearly depicts the sites observed and sampled by MECDM in 2019 and need to continue monitoring annually. Trends of improvements or worsening help inform policy decisions on the impact of policy interventions particularly those set out in the Mataniko Integrated Management Plan. The consistency of using the same sites provide for more useful comparison spatio-temporally.
